THE CARACOL
AT CHICHEN ITZA, YUCATAN,
MEXICO

BY
KARL RUPPERT

PUBLISHED BY
CARNEGIE INSTITUTION OF WASHINGTON
1935

CARNEGIE INSTITUTION OF WASHINGTON
PUBLICATION No. 454

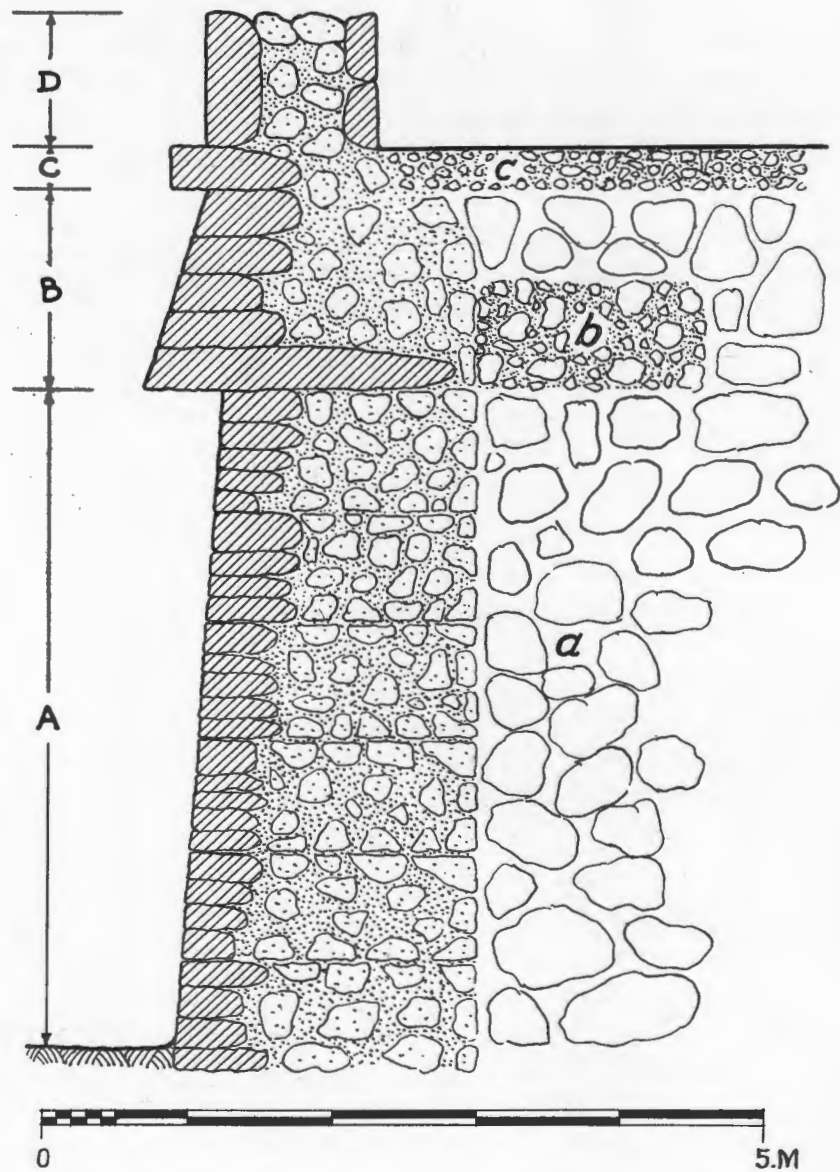
FIG. 8—SECTION THROUGH FACING OF LOWER PLATFORM.

A, lower zone; B, overhanging apron molding; C, band molding; D, parapet.
a, loose embutido inside of facing wall; *b*, pocket of small stones; *c*, small stones with much mortar directly beneath lime plaster floor.

Resting on the apron molding is a 30-cm. band which overhangs 25 cm. (figs. 8 C and 11). The facing of the band shows a slight batter at some points, but it was not deter-

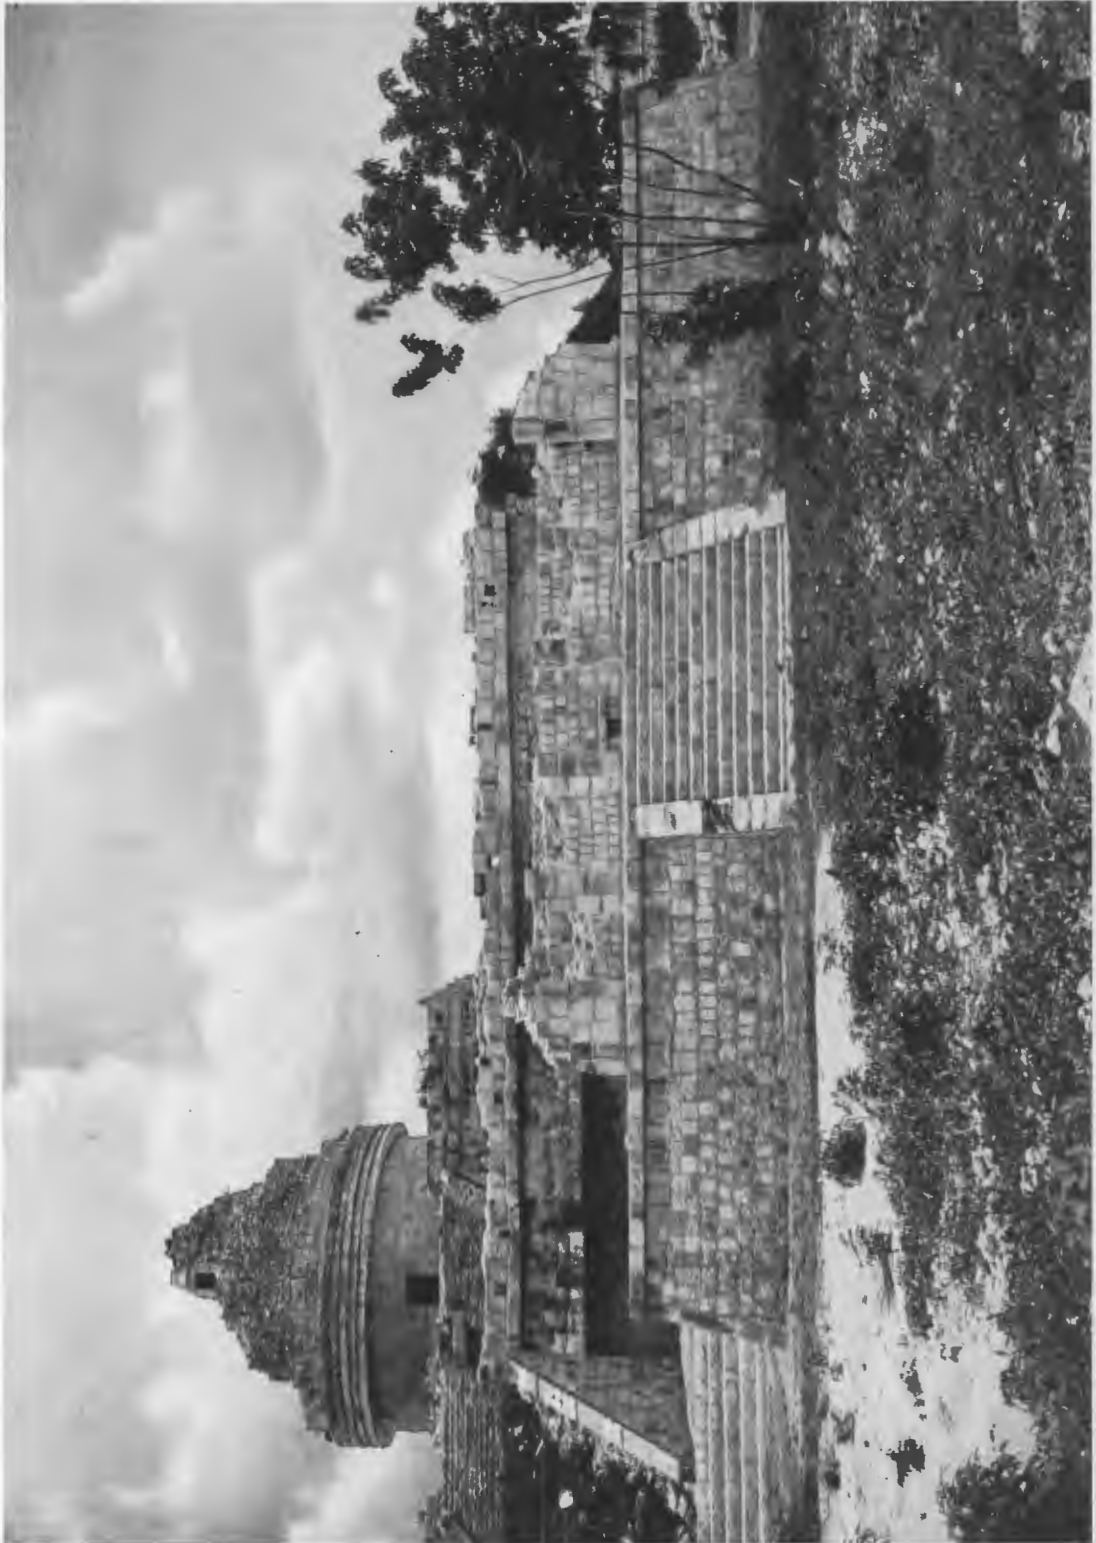
FIG. 13—CARACOL AND WEST ANNEX.
On the west side, south of the stairway, four small drains were found opening through parapet of lower platform.

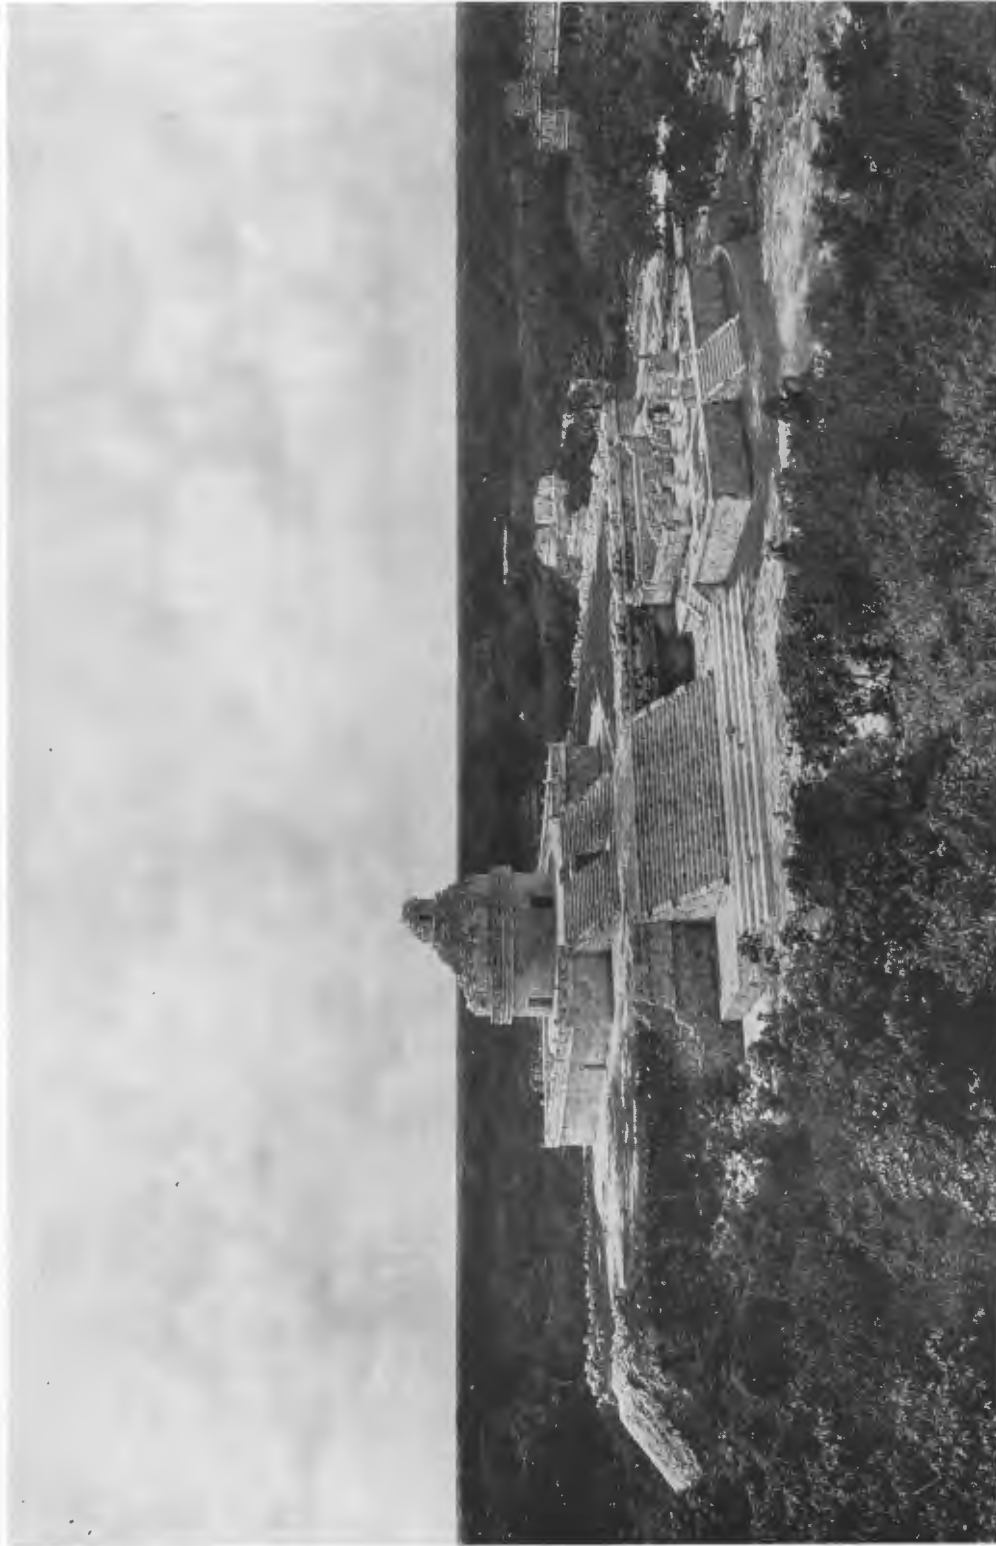
FIG. 55—CARACOL REPAIR COMPLETED AT END OF 1930 SEASON.
View from the Red House. Stairway of lower platform is centrally located on west side.

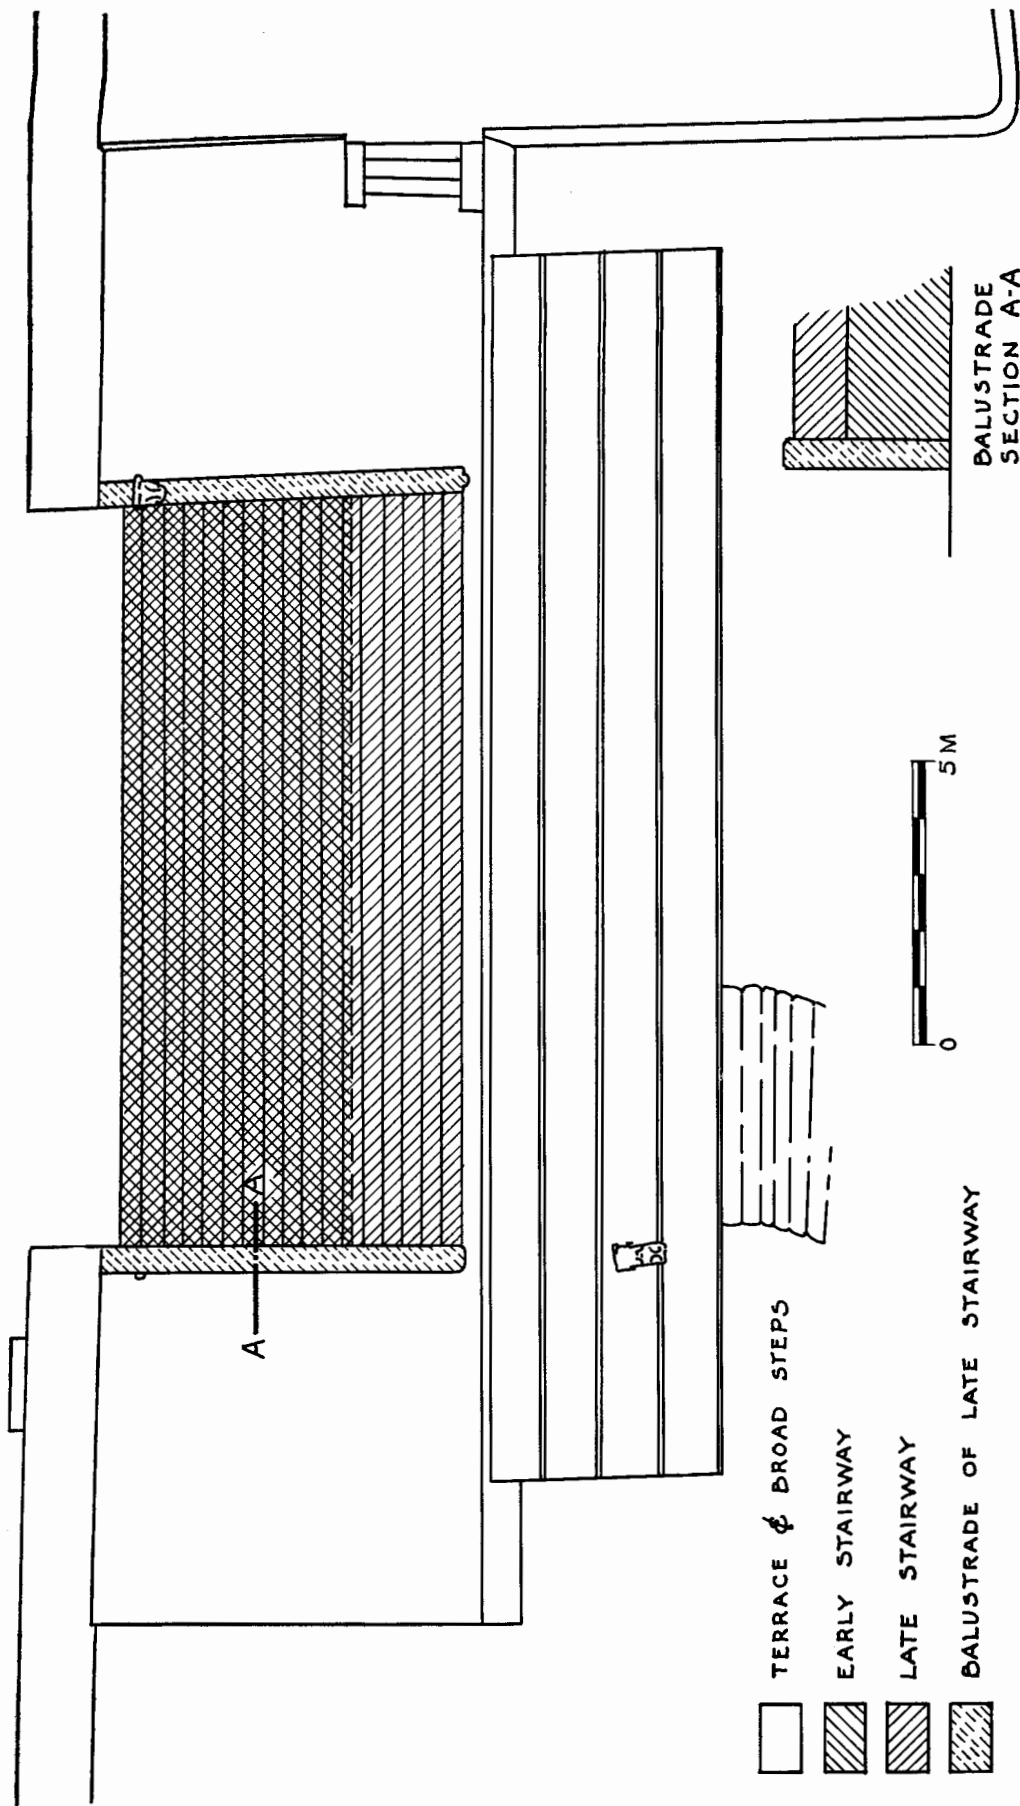
FIG. 67—PLAN OF LOWER PLATFORM STAIRWAY SHOWING SUCCESSIVE STAGES OF GROWTH.

A flight of steps rising from the low platform remained to be constructed before access could be gained to the great main platform (figs. 57 and 67). Investigations have shown that the first stairway built was torn out and replaced by a second. The early stairway had a width of 13.56 meters, which was indicated by remains of its facing walls at either side (fig. 68, *a*, showing north side). The walls are in line with the ends of the masonry buttress, are built against its west face and give off directly therefrom (fig. 56, *b*) and, while partially razed, were found extending to within 2.97 meters of the western edge of the low platform (fig. 69). The plastered floor of the low platform, which was applied at that time, rounds up against the side walls of the stairway. As the floor associated with the walls is known to have extended only slightly over 2.30 meters inward from the edge of the low platform it is a fair assumption that 67 cm. of the facing wall was removed when the stairway was razed.

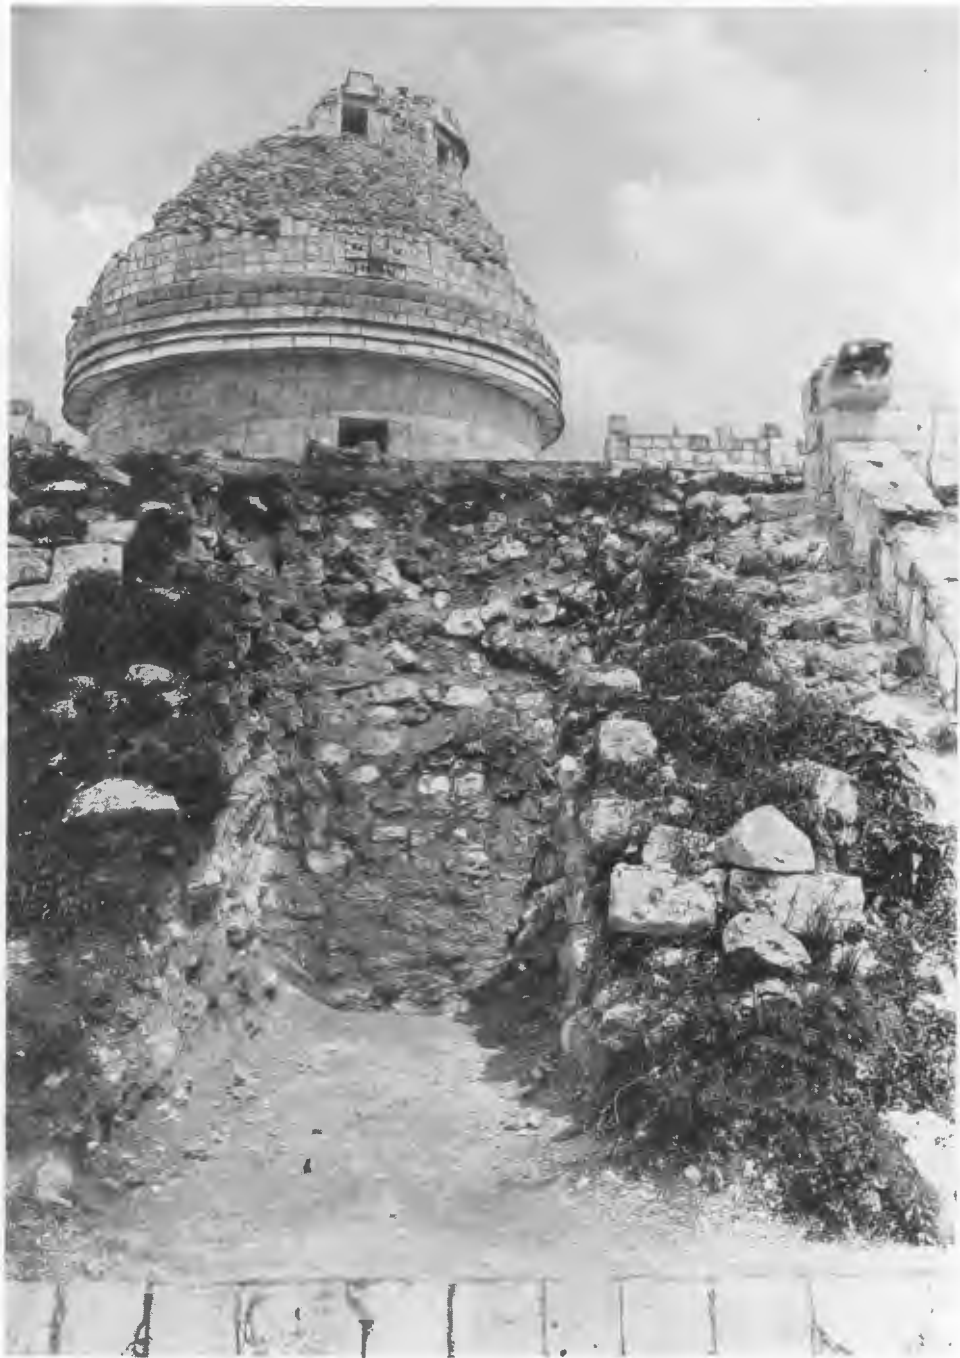
FIG. 79—STAIRWAY OF LOWER PLATFORM.
Trench exposing buttress and vertical wall behind stairway.

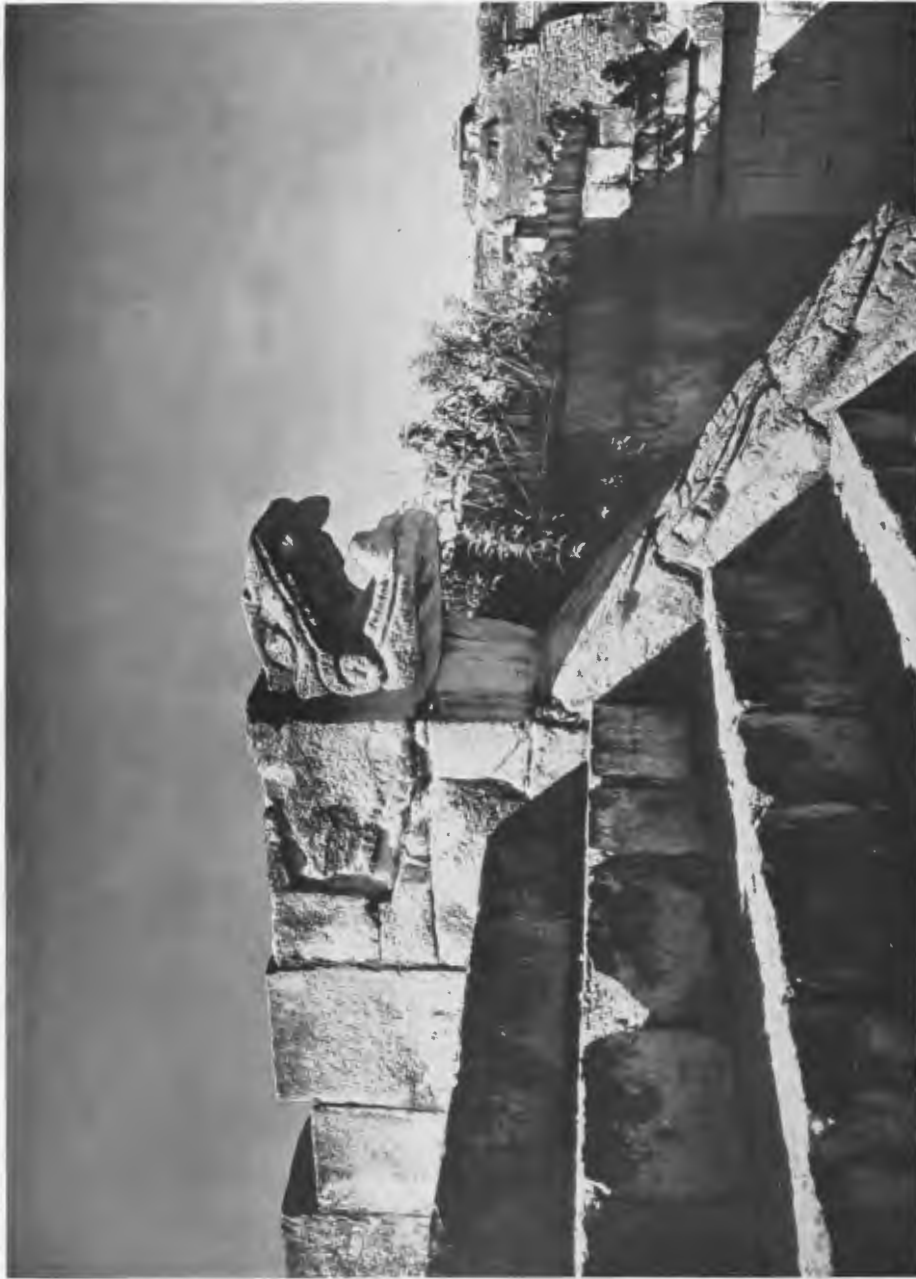
FIG. 86—LOWER PLATFORM STAIRWAY.
Serpent head replaced at top of south balustrade.

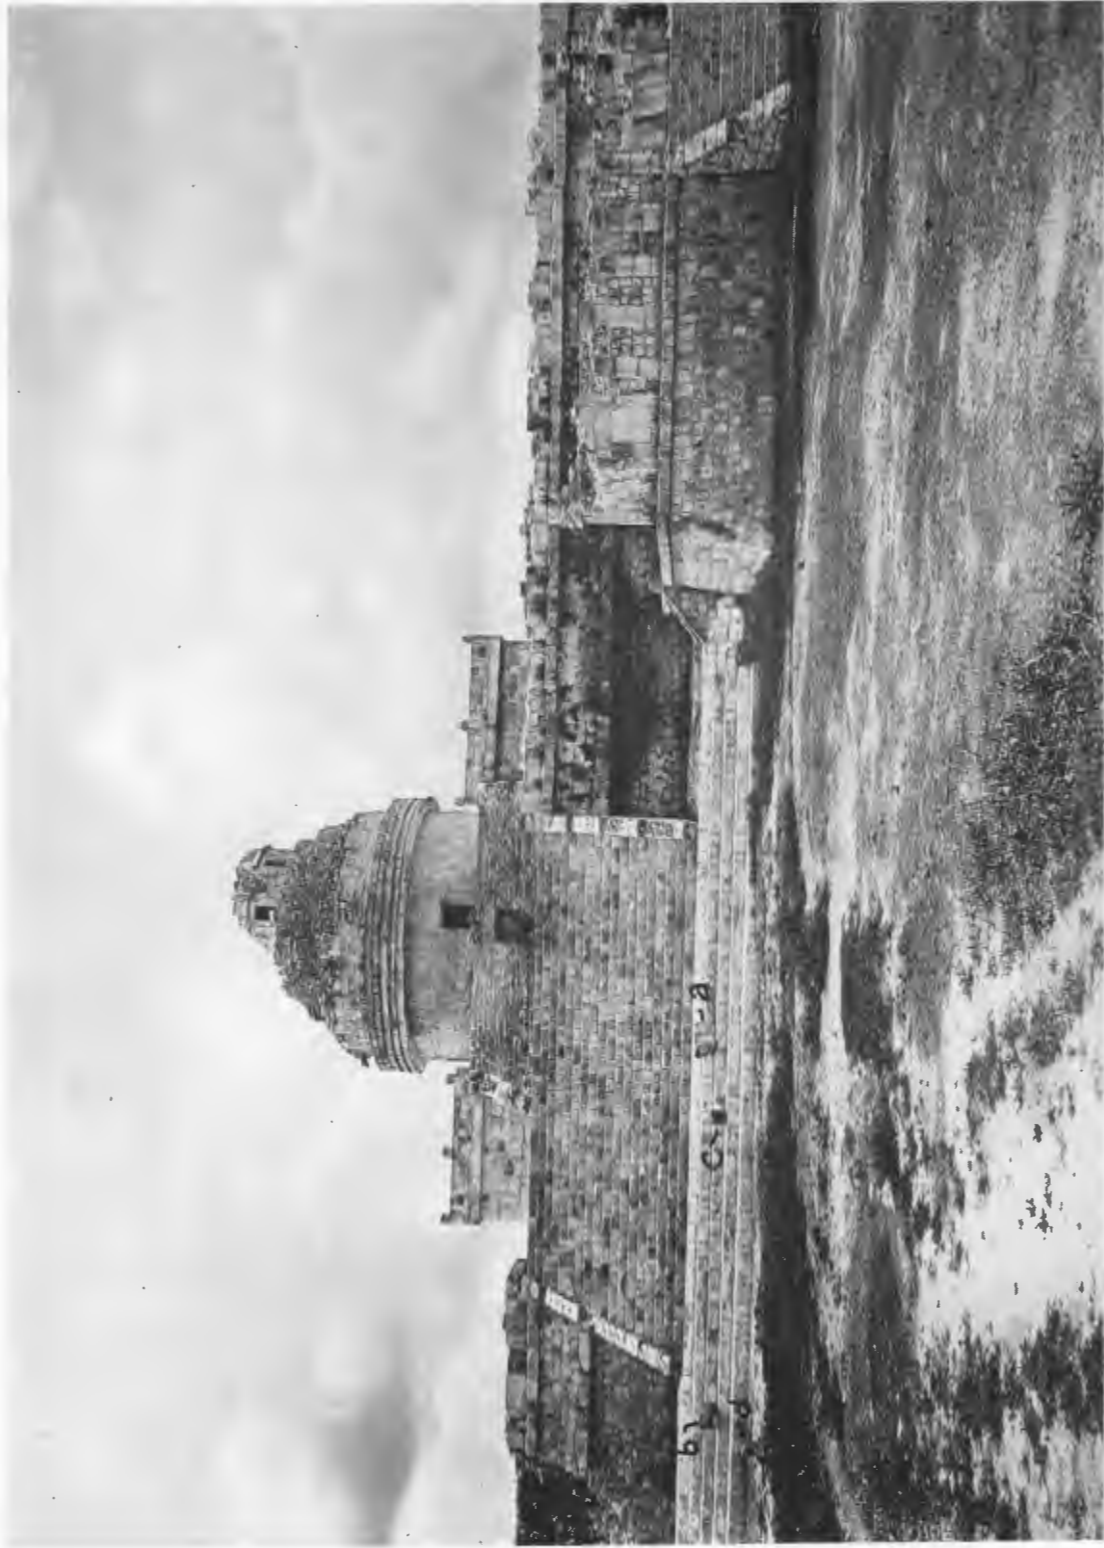
FIG. 87—LOWER PLATFORM STAIRWAY SHOWING FOUR SERPENT HEADS RECOVERED DURING EXCAVATIONS.
a, serpent head with great square tenon; *b*, serpent head found on second broad tread of the stairway and in line with north balustrade; *c*, small serpent head found on second broad tread of the stairway; *d*, small serpent head found on the *sache*. All heads were left where found

to the north. Even though no stones sculptured with the intertwining serpent motif were found between the serpent head on the second tread of the broad steps (fig. 87, *b*) and the stones found *in situ* at the base of the north balustrade, it is possible that the sculptured stones continued to such heads for both balustrades and were later removed, or the gap may even have been filled with plastered rubble.

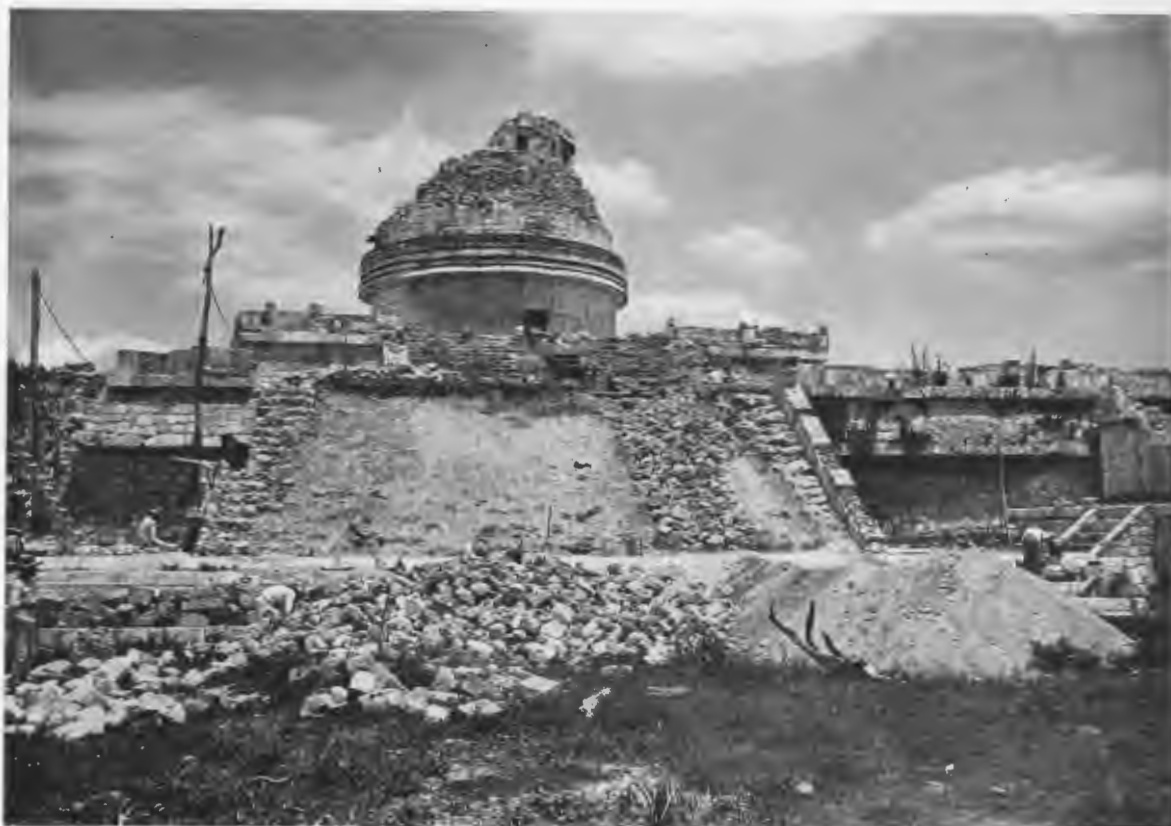
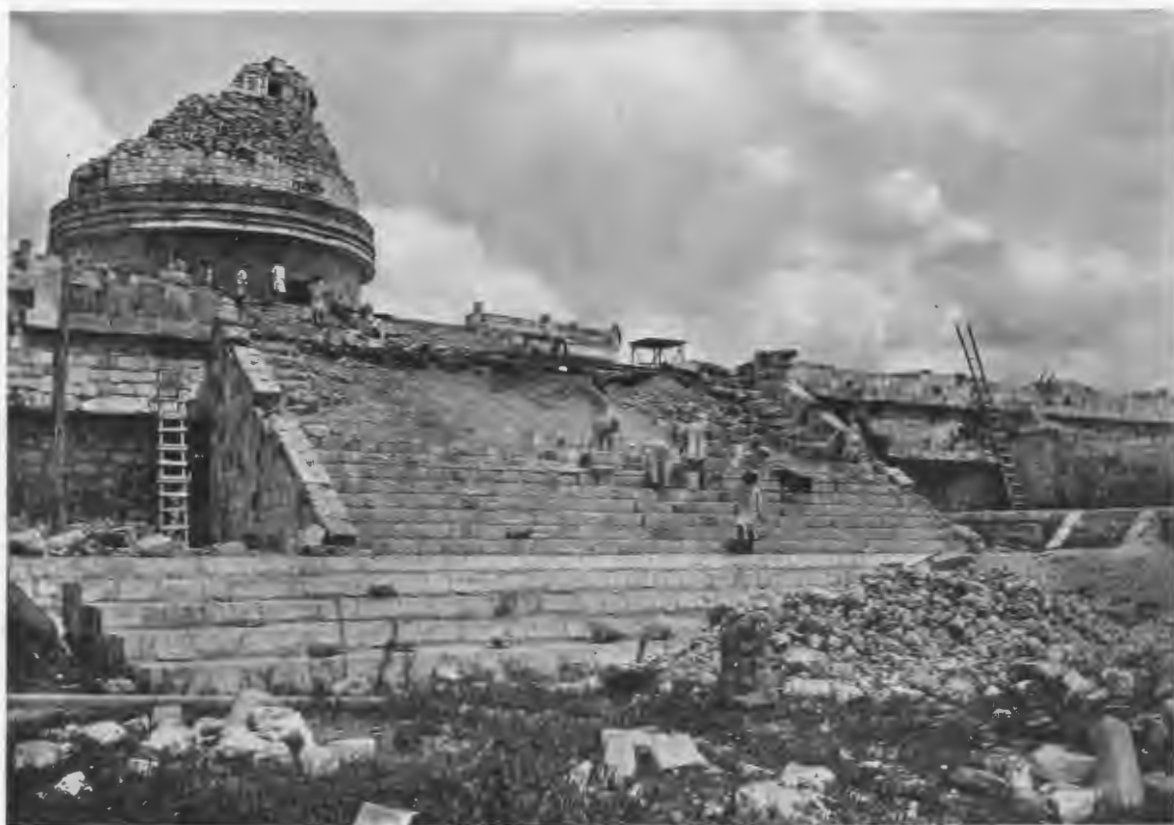
FIGS. 88 AND 89—REPAIRING LOWER PLATFORM STAIRWAY.

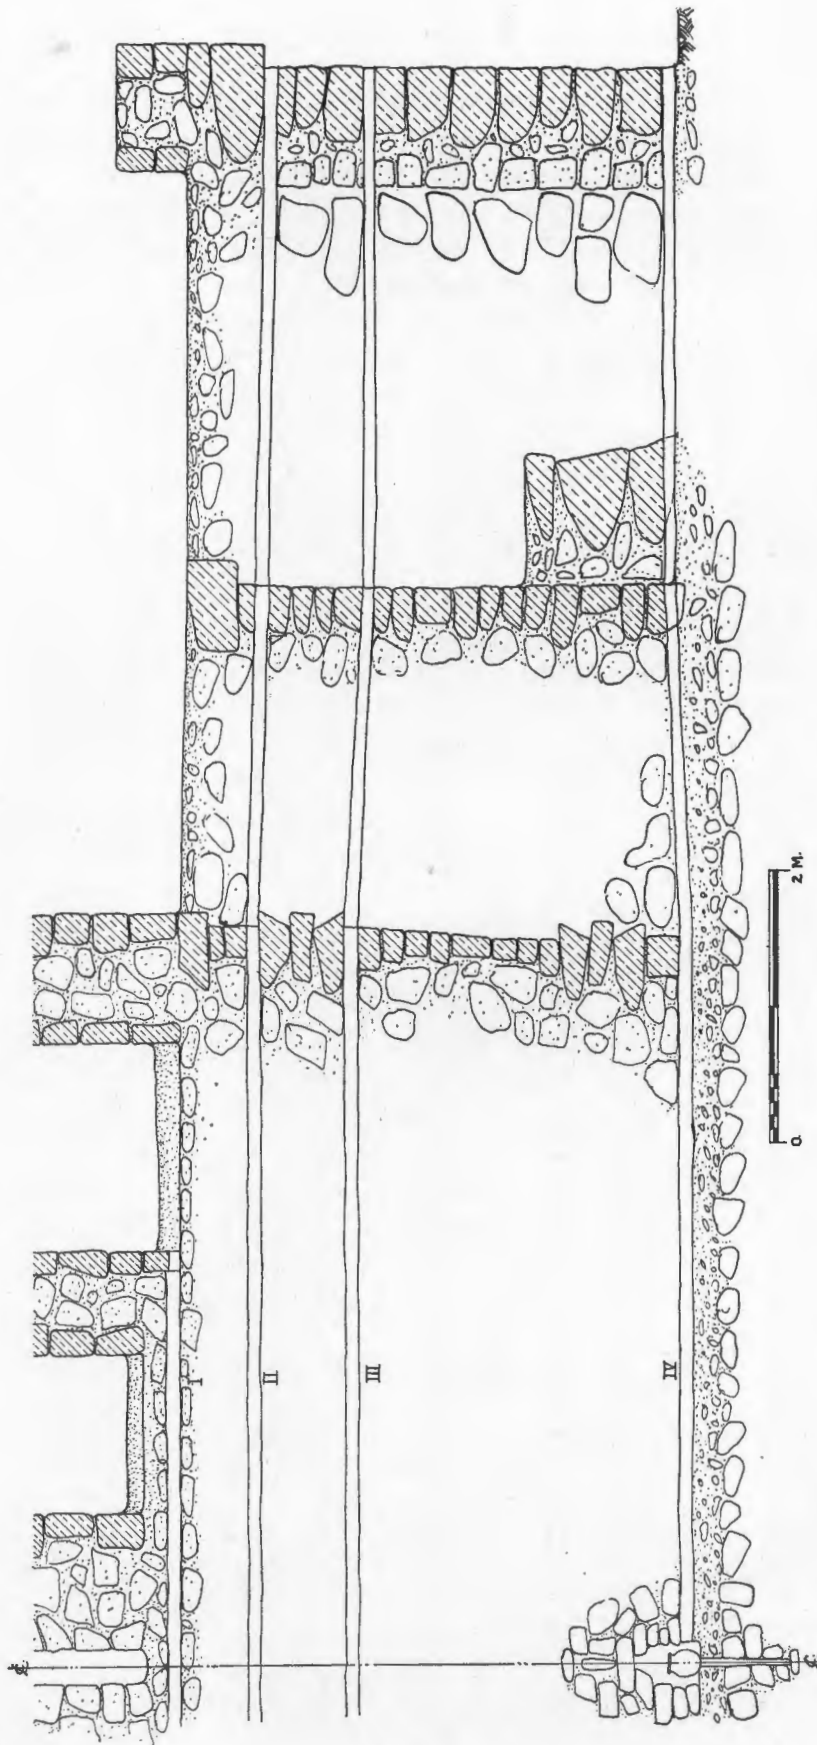
FIG. 99—DIAGRAMMATIC SECTION THROUGH HALF OF UPPER PLATFORM SHOWING LOCATION OF FOUR LEVELS OF WEEP HOLES.

The weep holes, in general, originate somewhere near the center of the platform and radiate to its periphery, not, however, always in a straight line nor horizontal. As the upper or the lower margin is formed by either the top or bottom of a task, the levels are relatively constant. The shafts average 10 cm. in width by 20 cm. in height. The masonry is merely the rough *embutido* of the platform left unsurfaced, except for a short distance inward from the orifice, where the shaft is usually plastered and carefully smoothed.

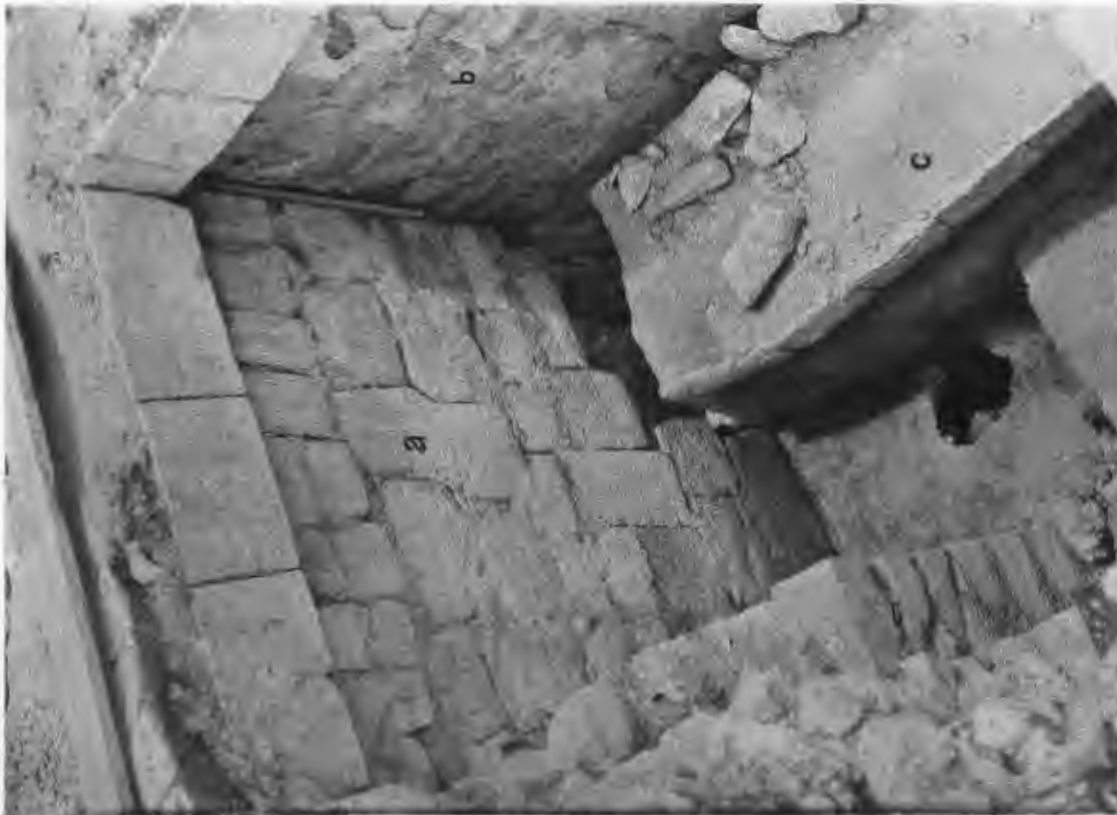
FIG. 111—*a*, south portion of east wall of the rectangular platform; *b*, second circular platform; *c*, bench of second circular platform.

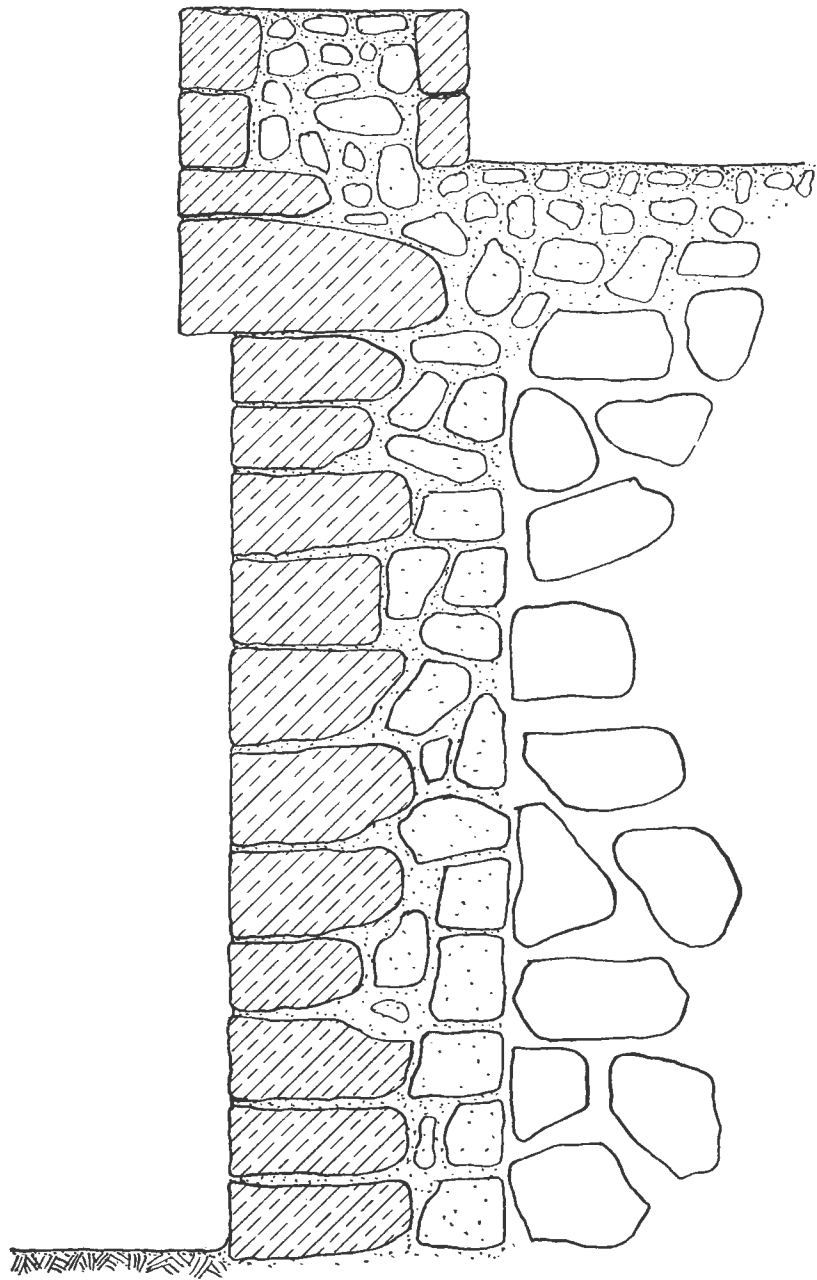
FIG. 127—SECTION THROUGH FACING OF UPPER RECTANGULAR PLATFORM.

The floor on the top of the platform is 54 cm. above the base (fig. 127), or 20 cm. above the top, of the first course of the cornice of the final rectangular platform, the top of this first course of stone being at the same level as the top of the cornice of the outer circular platform (page 87; fig. 111). No floor level was noted at the top of the first course of the cornice associated with the western section of the rectangular platform, which is further

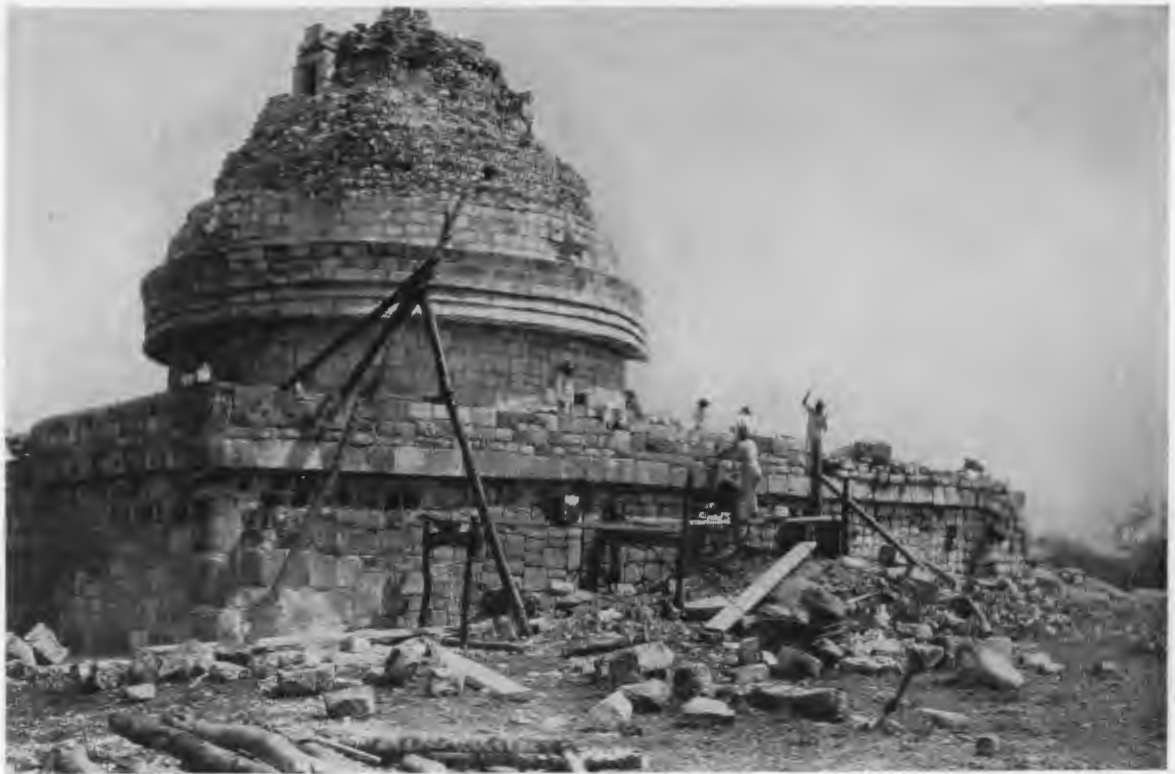
FIG. 135—UPPER PLATFORM, SOUTH SIDE, UNDER REPAIR.

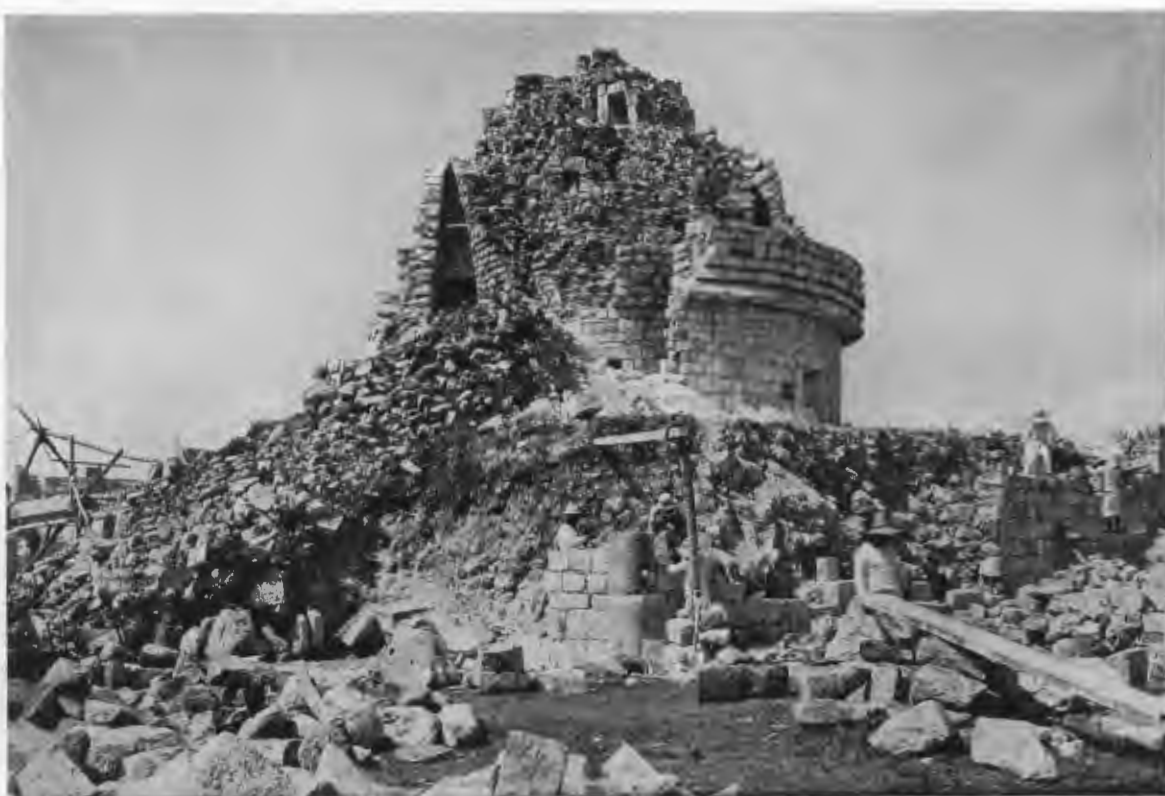
FIG. 138—REPAIR OF NORTHEAST CORNER OF UPPER PLATFORM IN 1929.

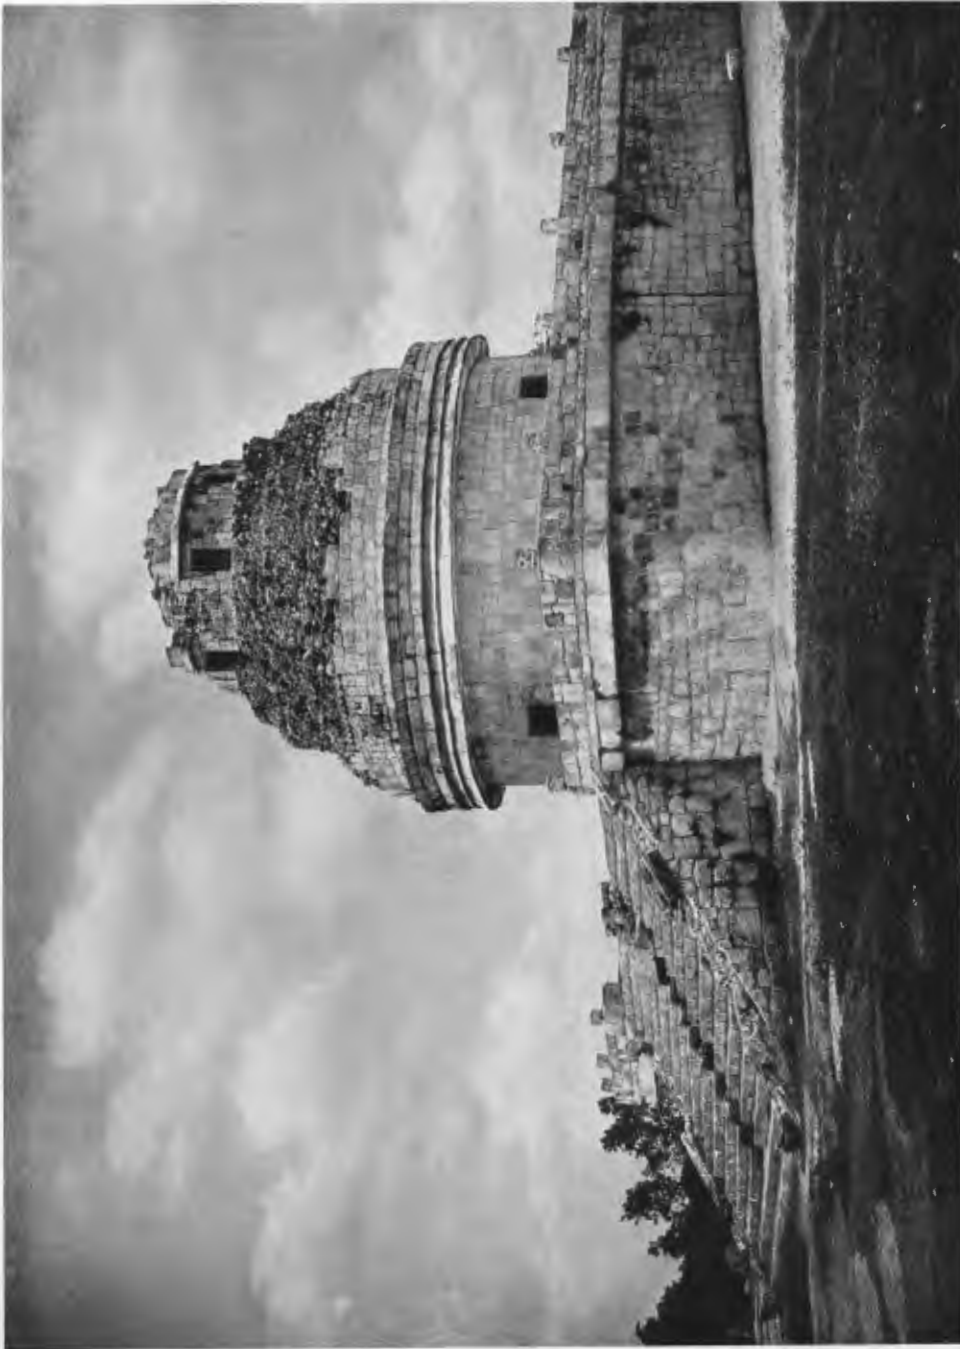
FIG. 158—UPPER PLATFORM AND TOWER REPAIRED.

Photograph of southwest corner taken in 1930.

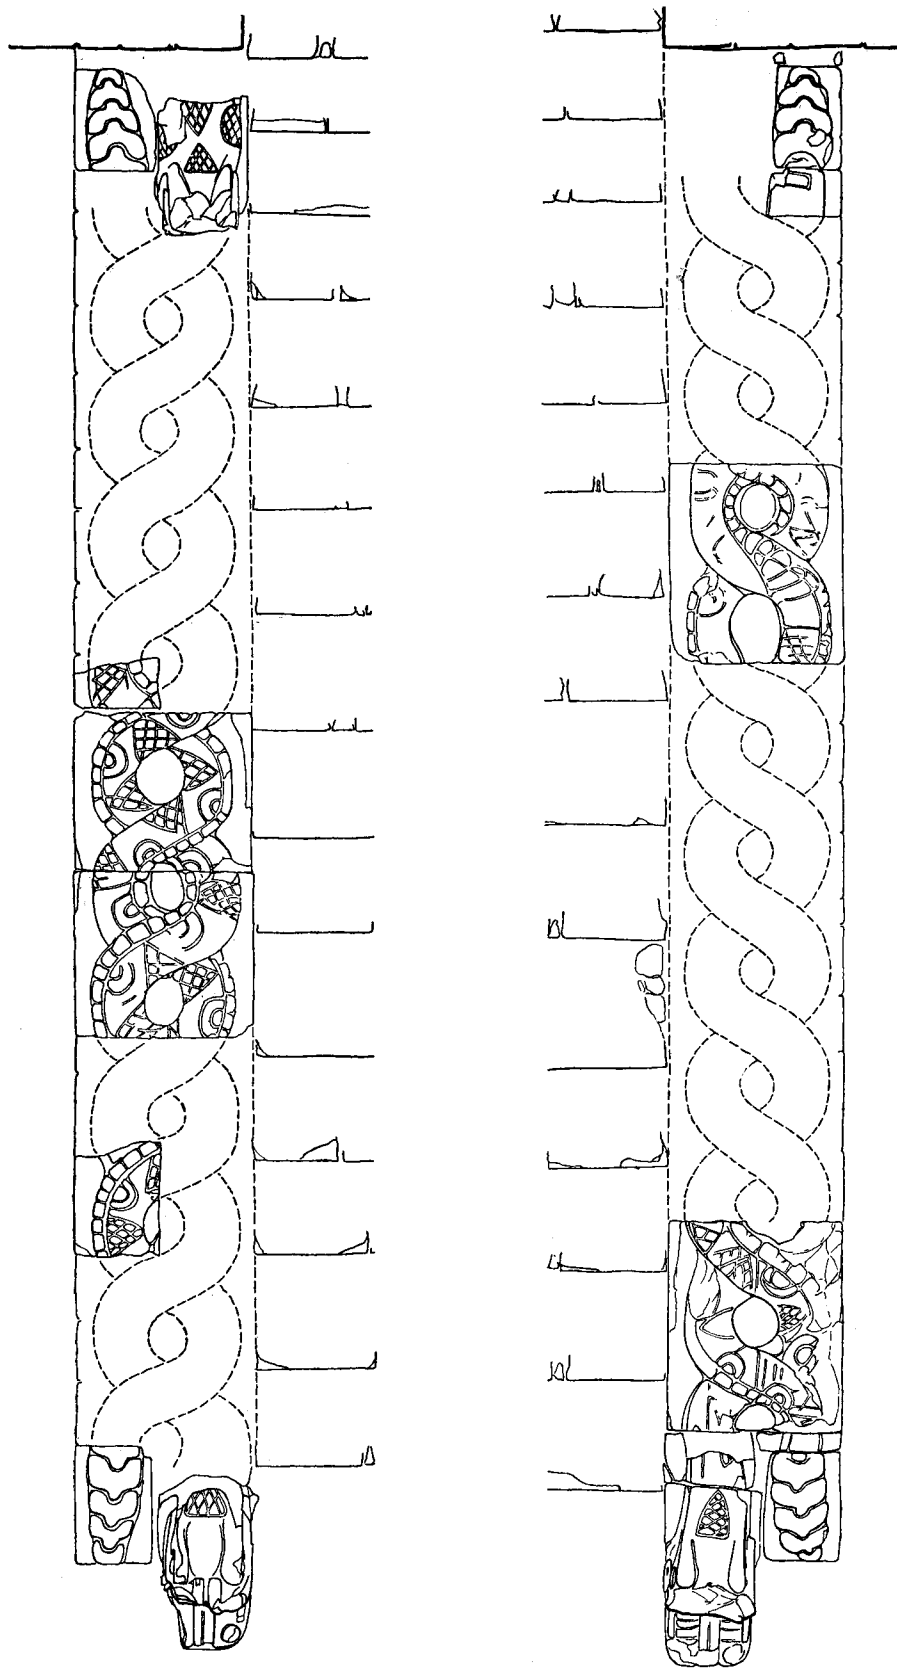
FIG. 159—SCALE DRAWING OF SERPENT BALUSTRADES OF UPPER PLATFORM STAIRWAY.

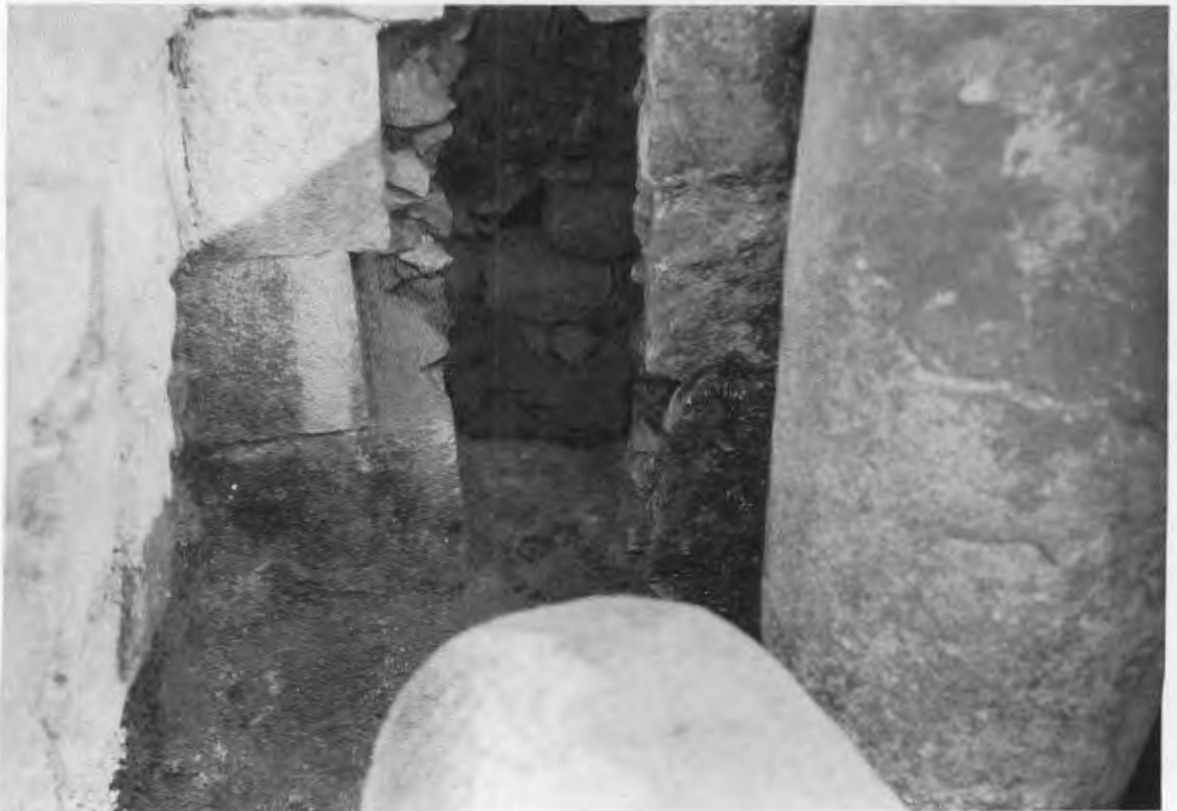
FIG. 182—EAST WALL OF NICHE PARTIALLY REMOVED TO SHOW THAT WALL RESTS ON STYLOBATE. EASTERN EDGE OF STYLOBATE SEEN THROUGH OPENING.

The east wall of the niche directly east of the columns rests on the stylobate 53 cm. inward from its eastern edge (fig. 182). On the north, the west face of the stylobate extends under the stairway and facing of the niche for a distance of 43 cm., while on the south it extends under the stairway and facing wall a distance of 27 cm. (fig. 162). The base of the north and south facing walls of the niche are here 15 cm. above the top of the stylobate (page 130), the floor of the niche covering the lower 20 cm. of the columns.
