THE CARACOL
AT CHICHEN ITZA, YUCATAN,
MEXICO

BY
KARL RUPPERT

PUBLISHED BY
CARNEGIE INSTITUTION OF WASHINGTON
1935

CARNEGIE INSTITUTION OF WASHINGTON
PUBLICATION No. 454

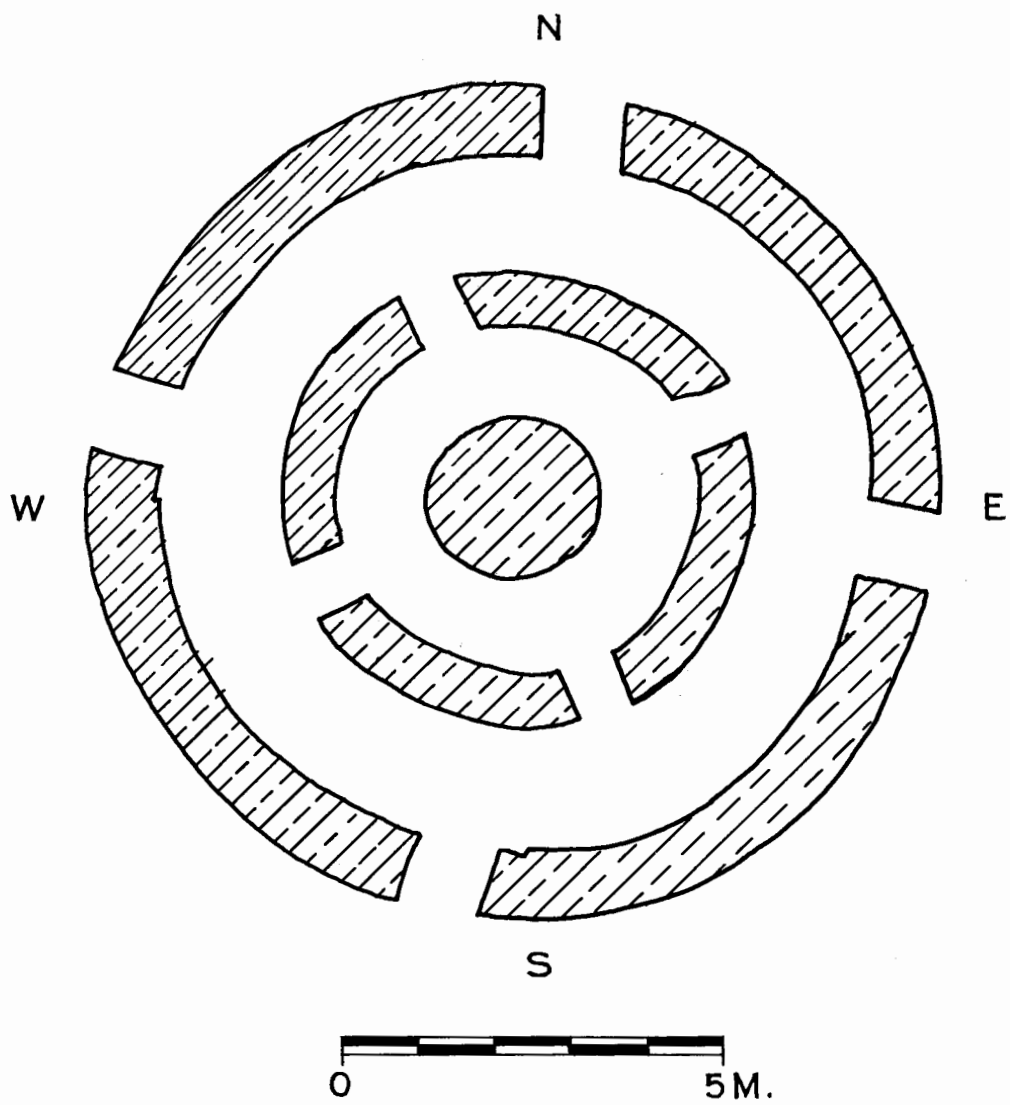
FIG. 183—PLAN OF TOWER.

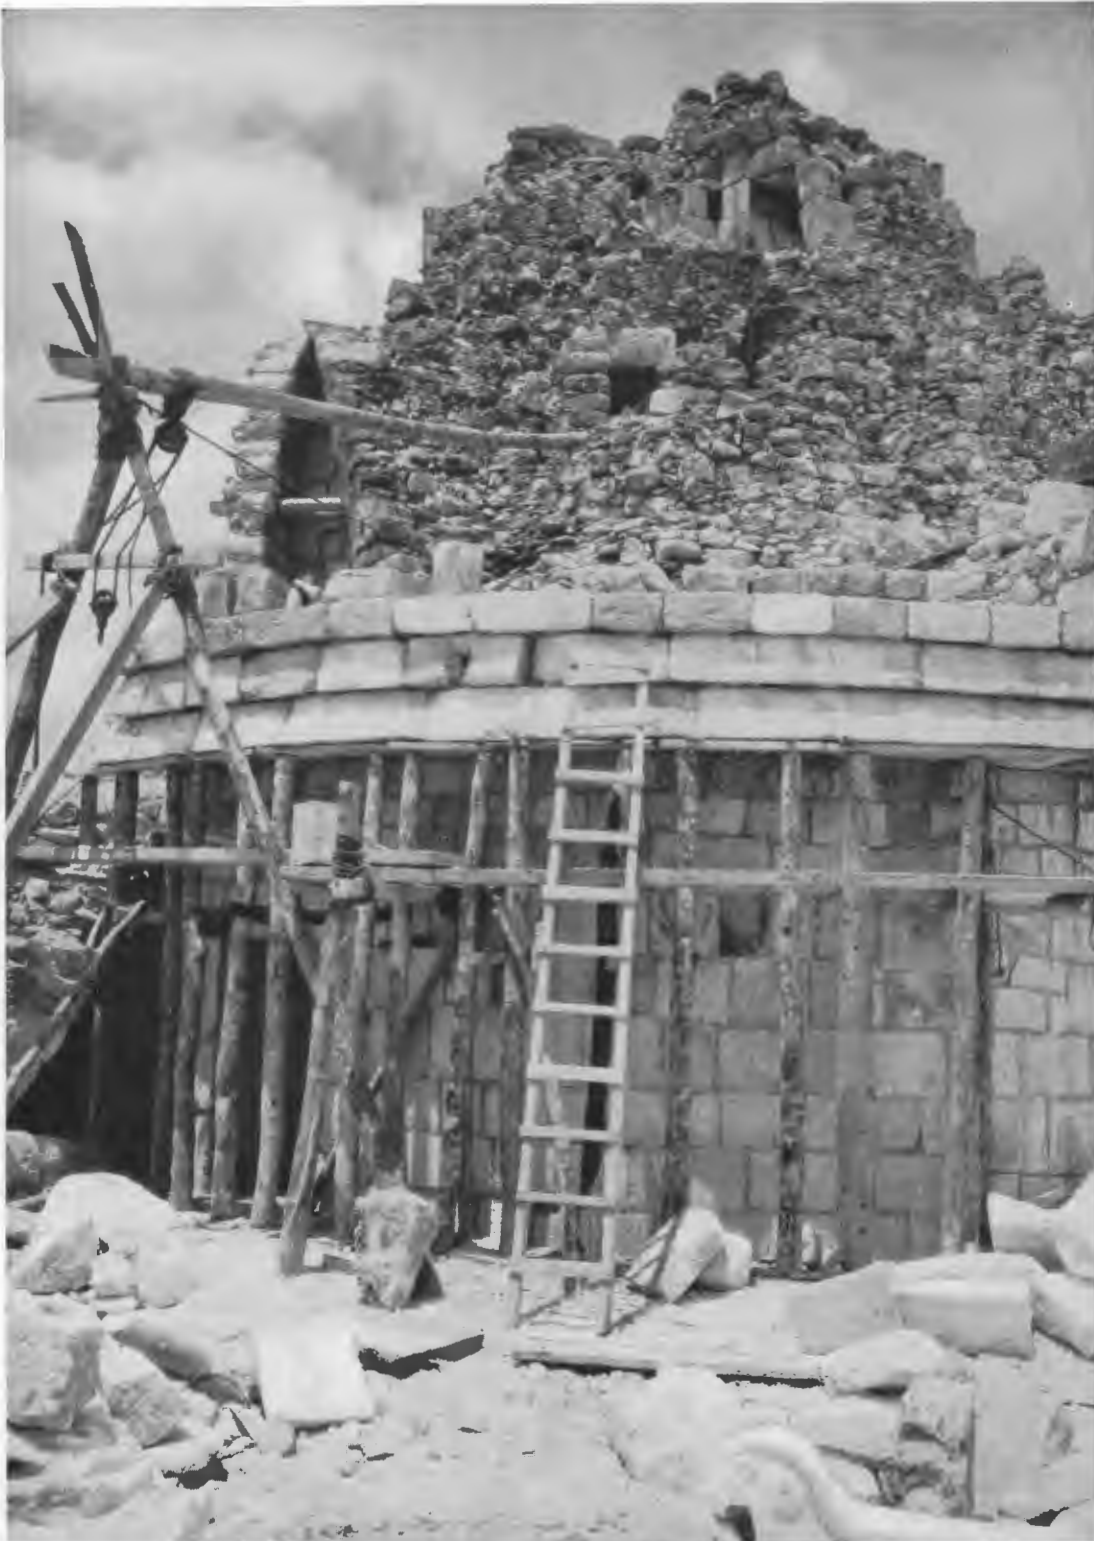
FIG. 207—CARACOL TOWER, NORTH SIDE, REPAIR OF FIVE-MEMBER MOLDING.
Wooden uprights were used to help support molding while being replaced and until cement mortar had set.

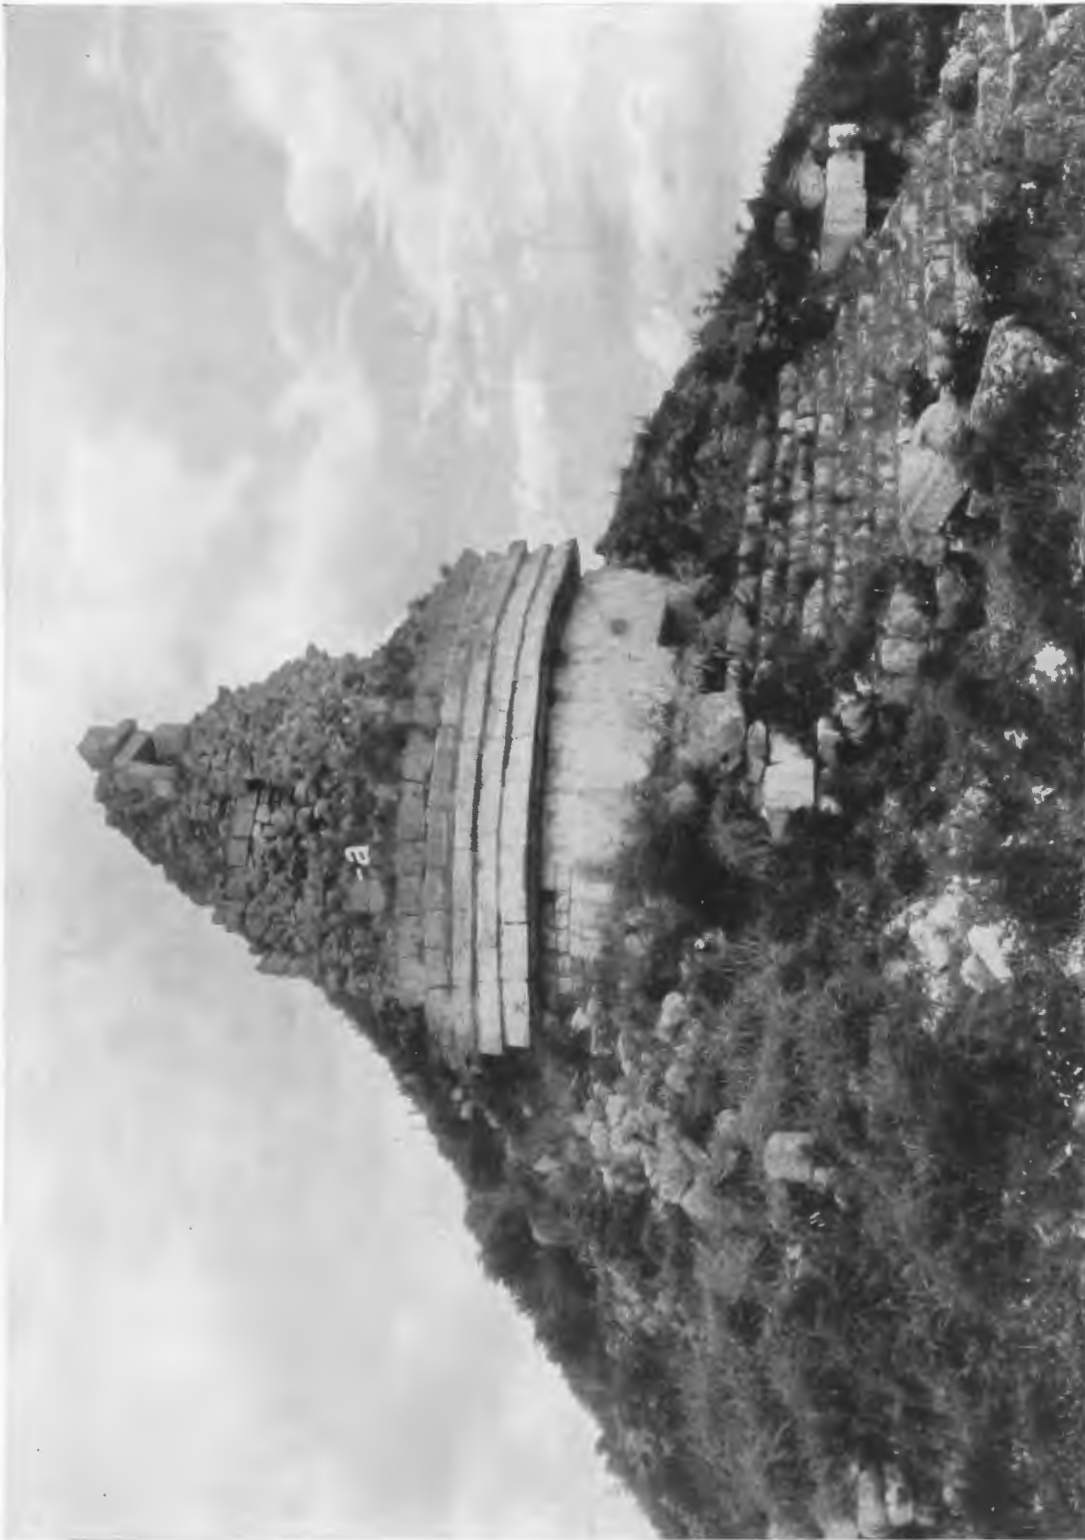
FIG. 219—CARACOL TOWER.
Three courses of vertical zone, *a*, above five-member molding were found *in situ*.

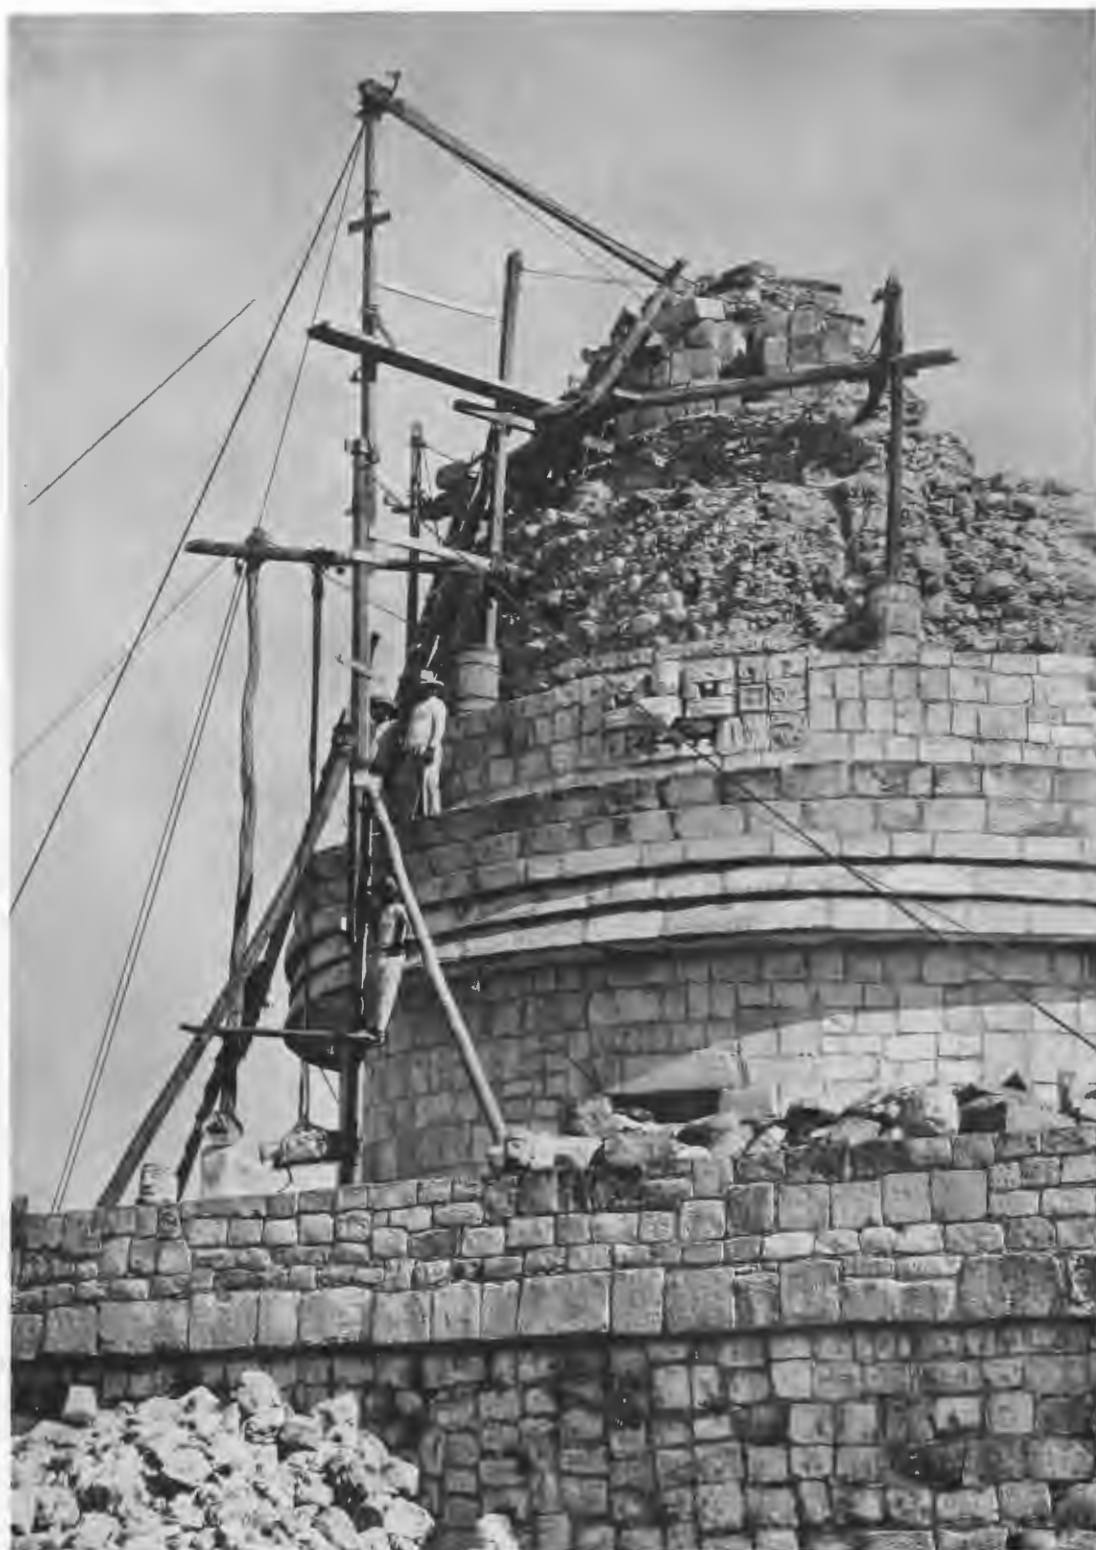
FIG. 242—CARACOL TOWER DURING REPAIR IN 1930.

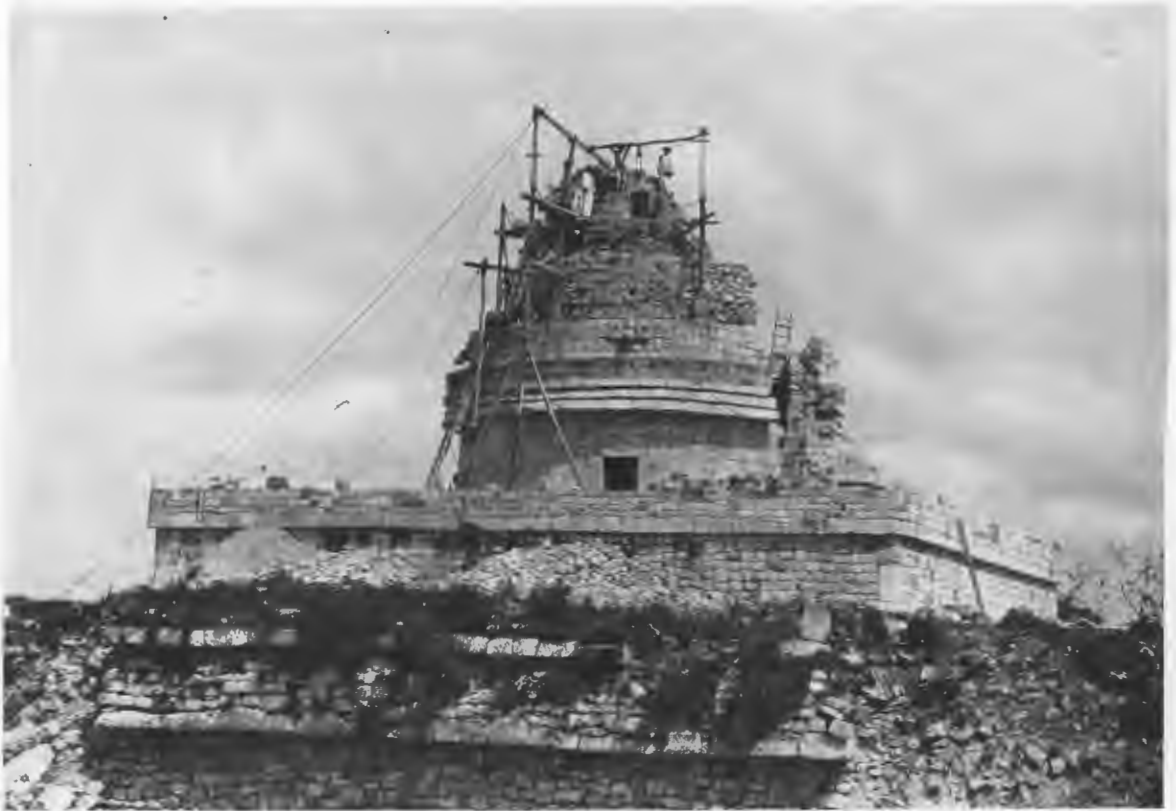
FIG. 243—CARACOL TOWER, SOUTH SIDE, DURING REPAIR.

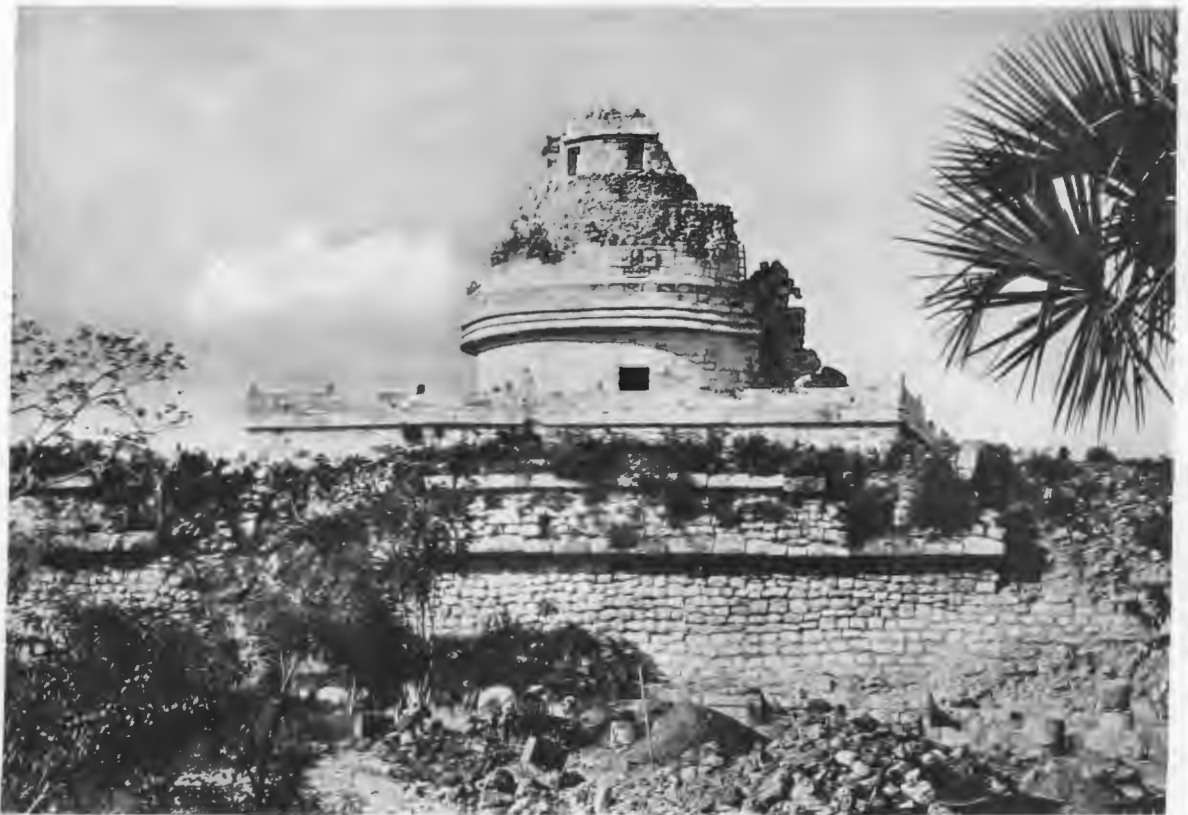
FIG. 244—CARACOL TOWER, SOUTH SIDE, REPAIR COMPLETED IN 1930.

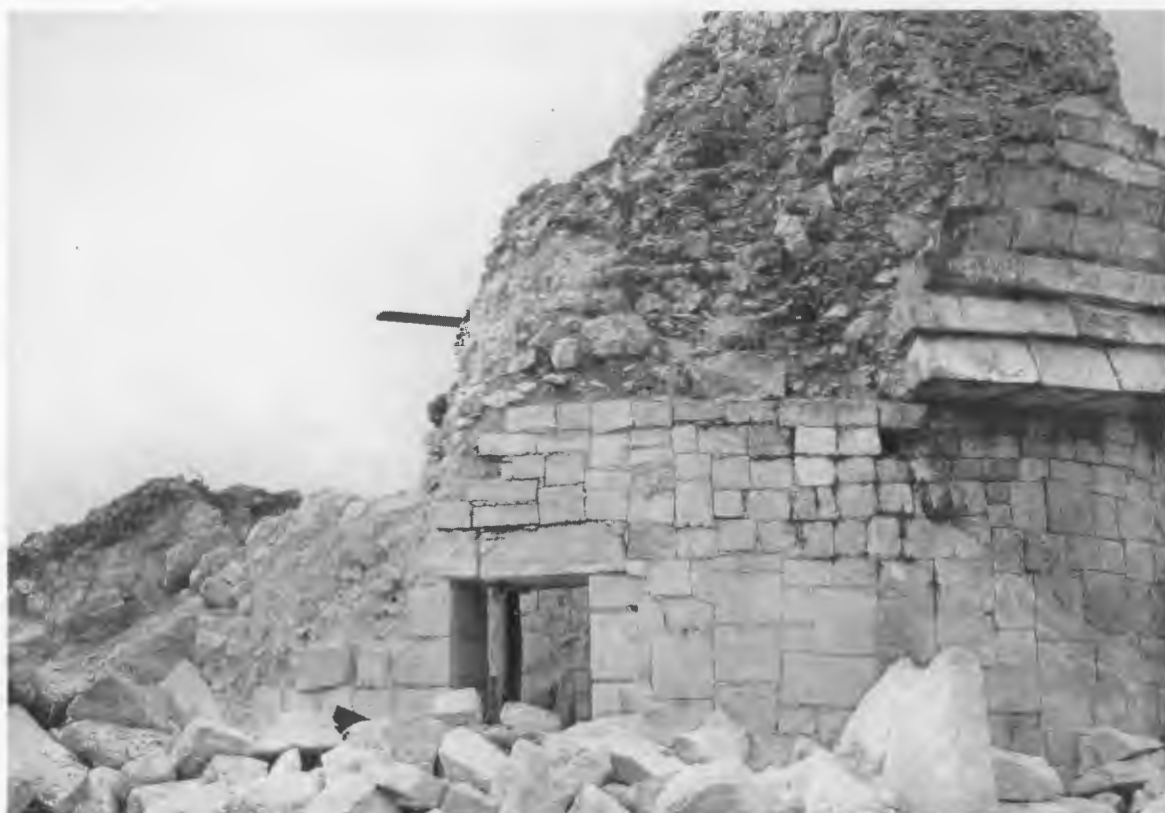
FIG. 247—NORTH DOORWAY, OUTER ANNULAR CHAMBER. THE LINTEL WAS FOUND BROKEN.

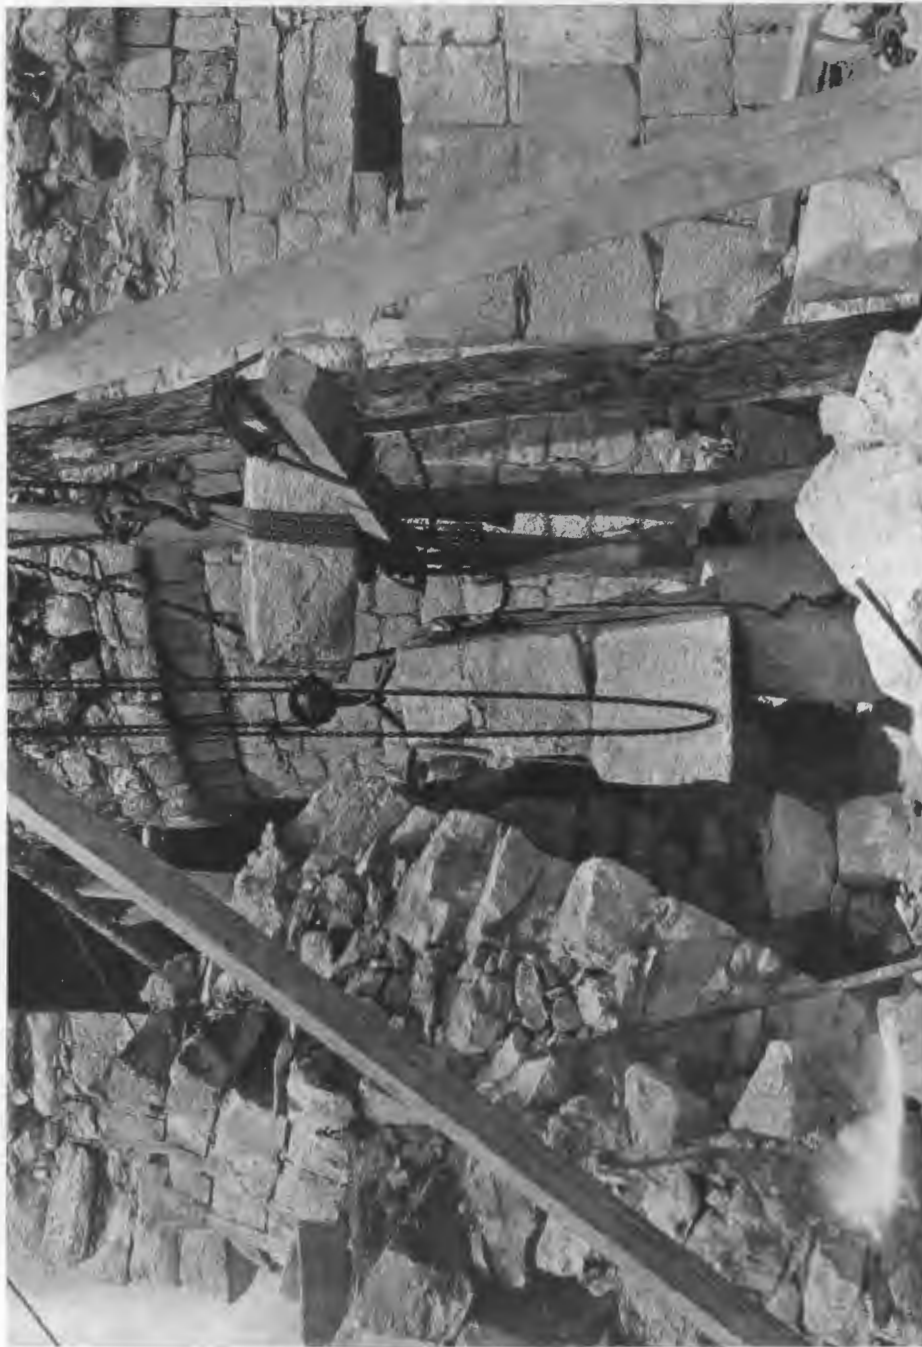
FIG. 252—CARACOL TOWER, REPAIR OF EAST DOORWAY.

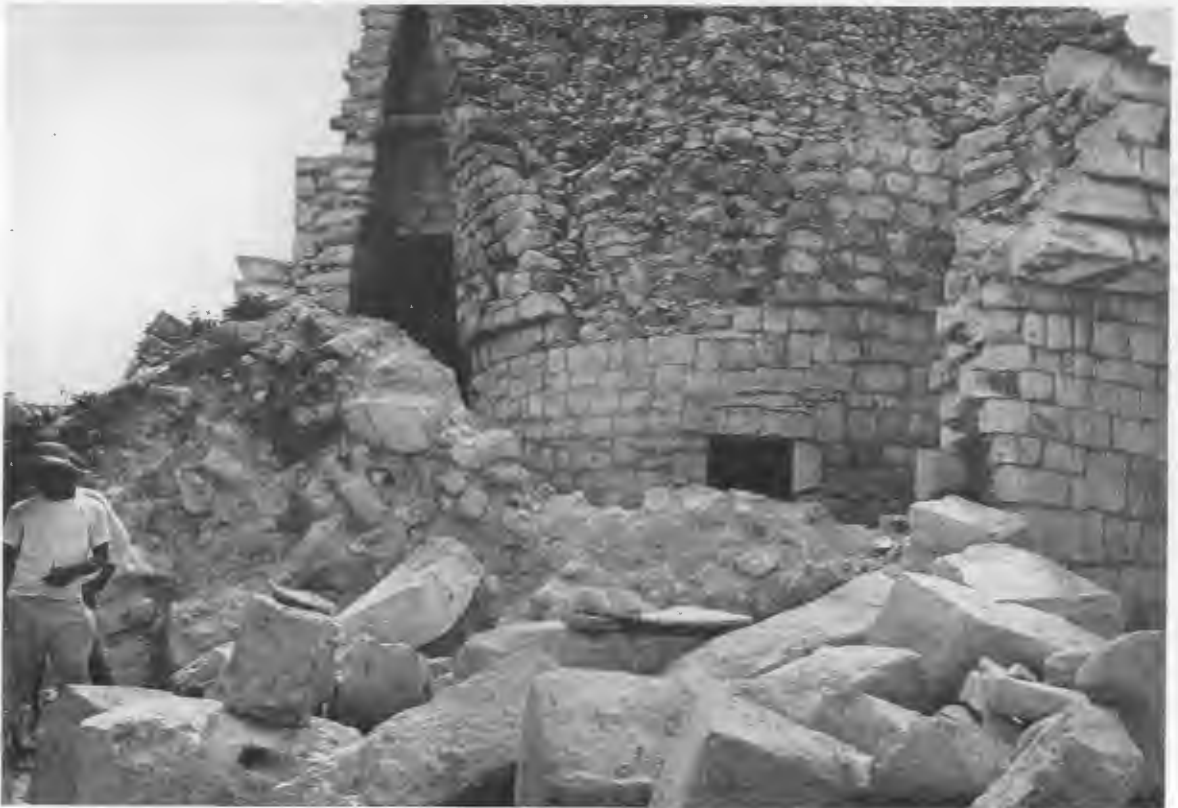
FIG. 264—NORTHEAST DOORWAY OF INNER ANNULAR CHAMBER. SOUTHEAST BUTTRESS HAS BEEN REPAIRED.

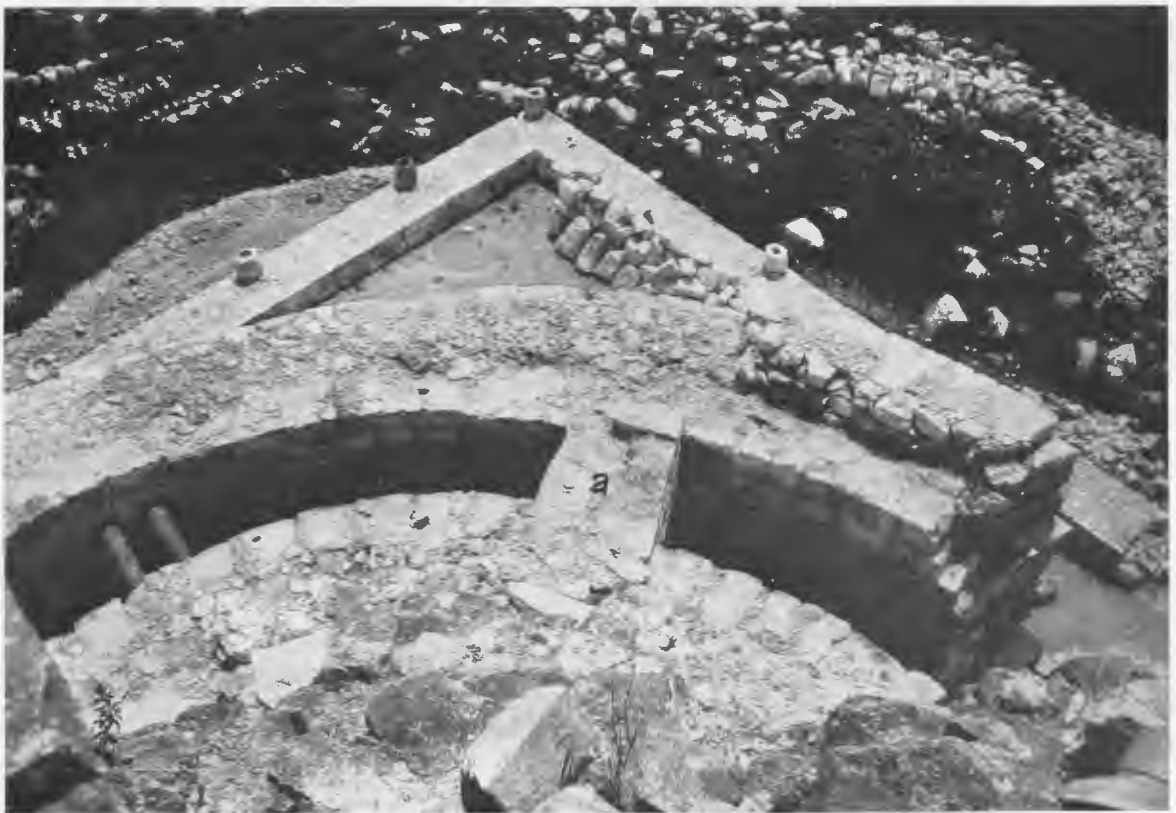
FIG. 265—INNER AND OUTER SLOPES OF ARCH IN NORTHEAST QUADRANT OF OUTER CHAMBER. Replaced to a height of 2.35 meters. The northeast buttress, *a*, was raised to the height to which the arch was restored.

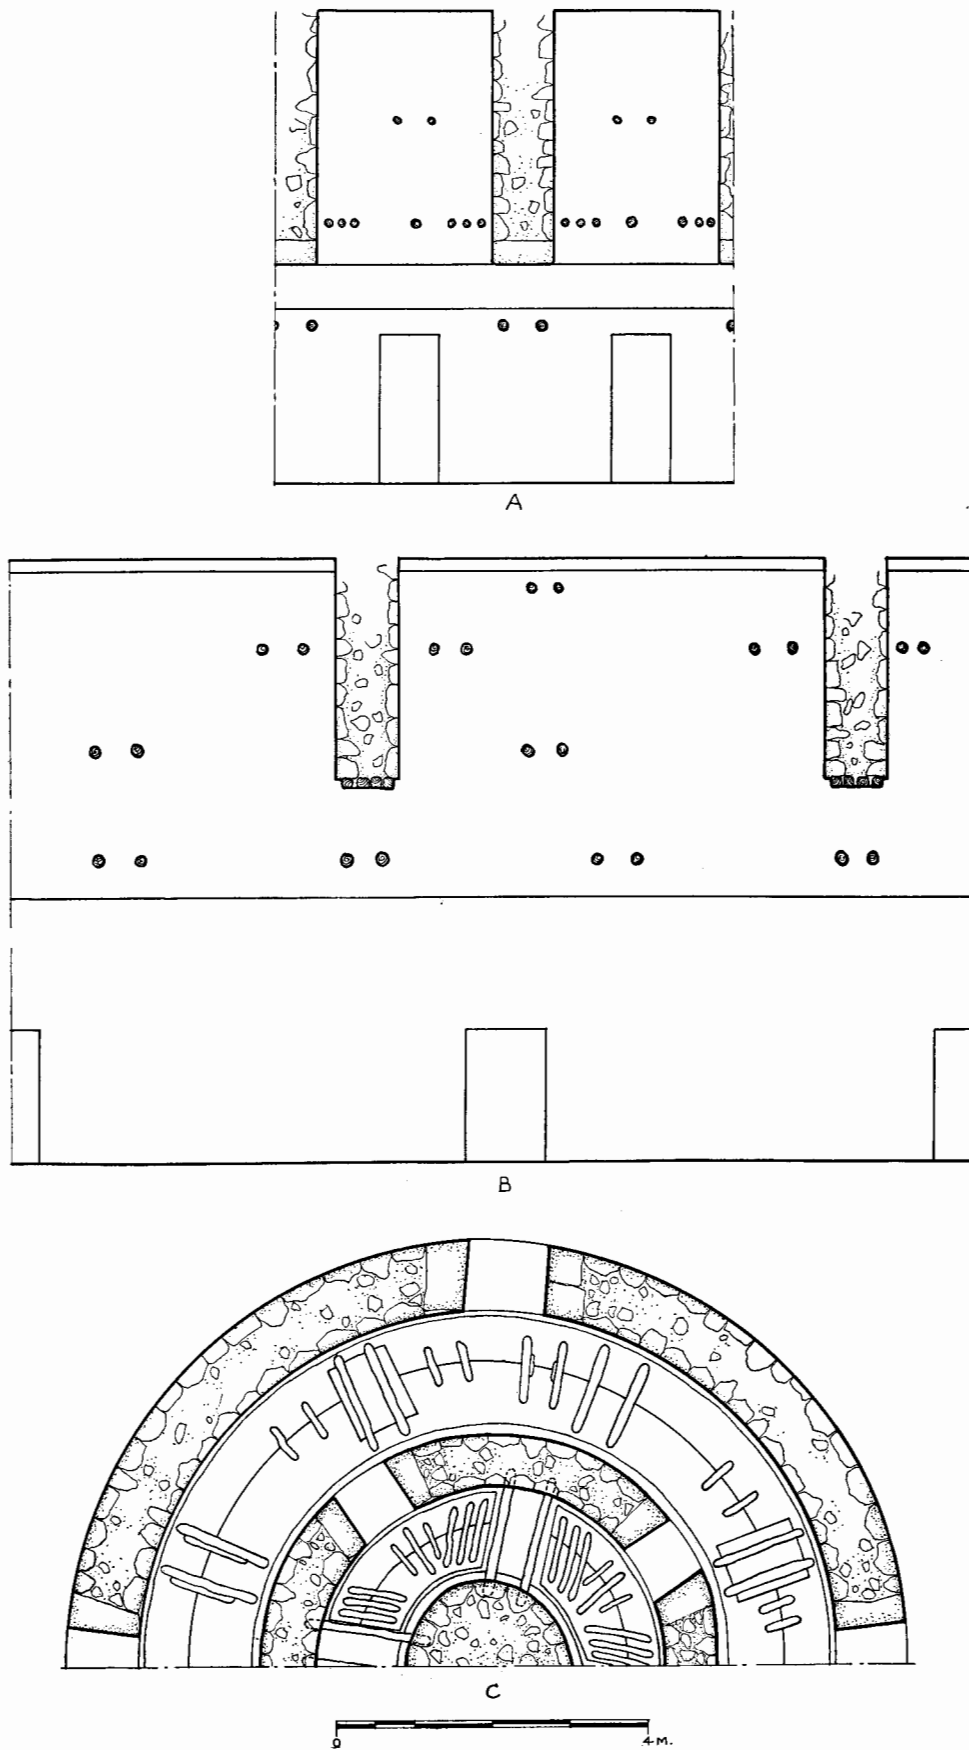
FIG. 266—PLAN THROUGH TOWER AND DEVELOPED ELEVATIONS OF CHAMBERS.

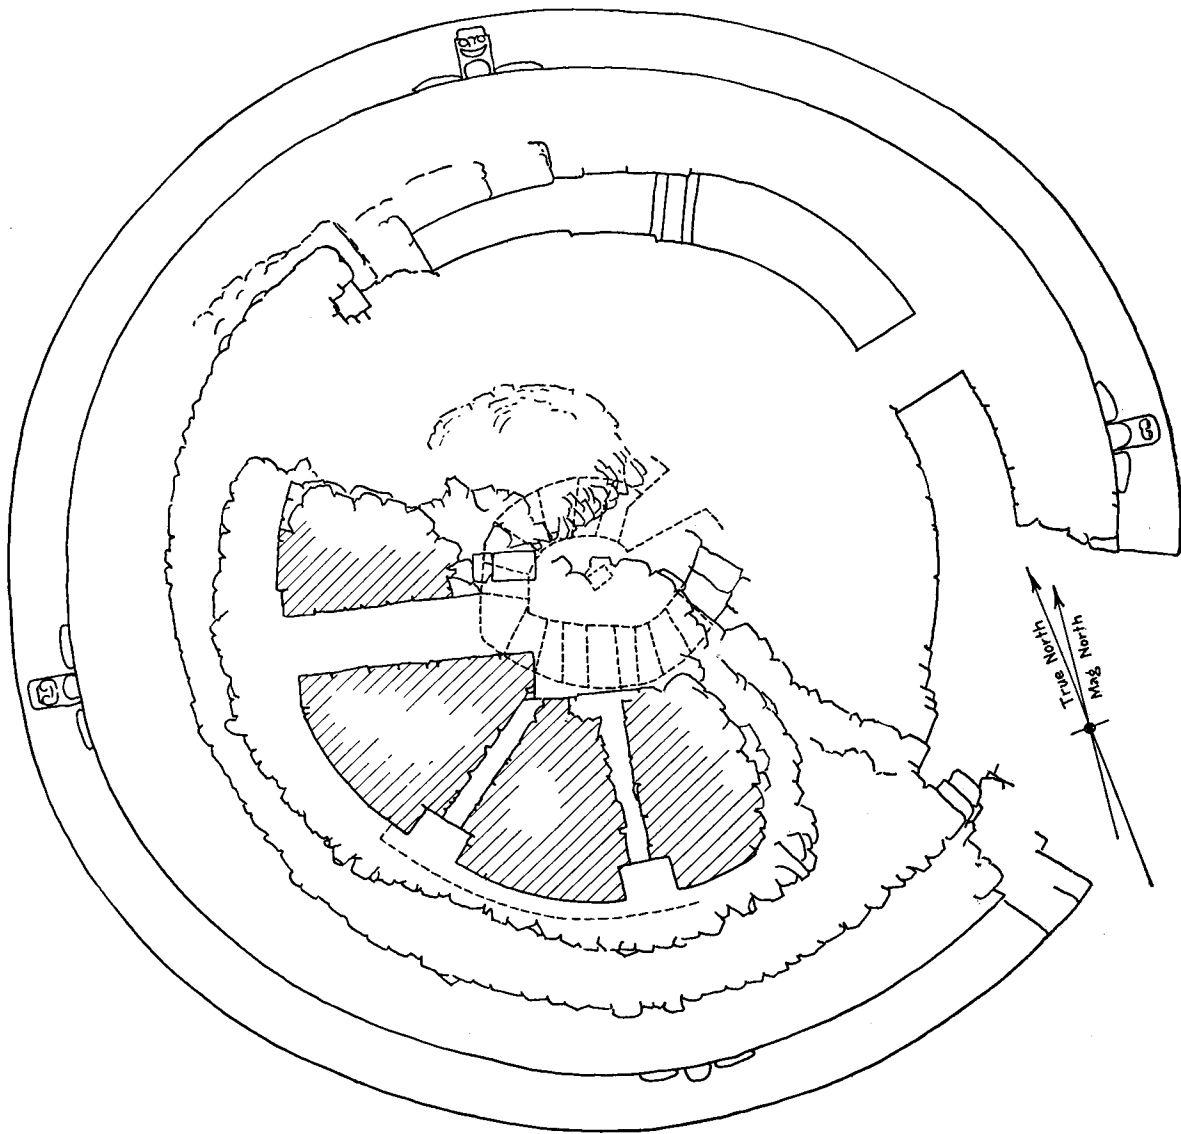
FIG. 287—SECTION THROUGH WINDOWS OF TOWER, LOOKING DOWNWARD.

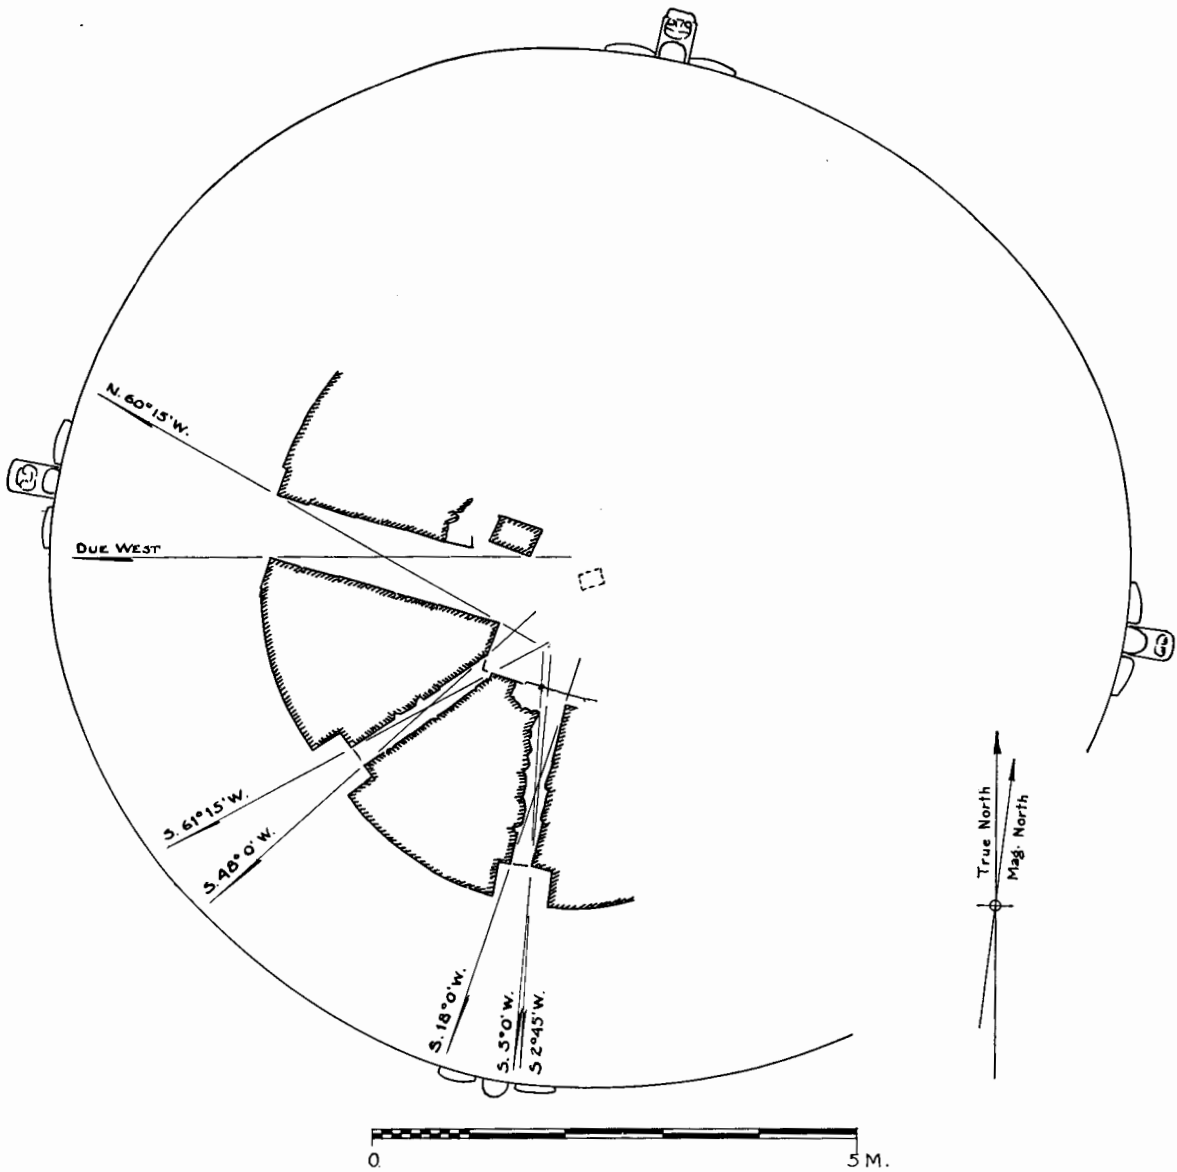
FIG. 293—PLAN OF WINDOW AND SHAFTS WITH TRUE BEARINGS.

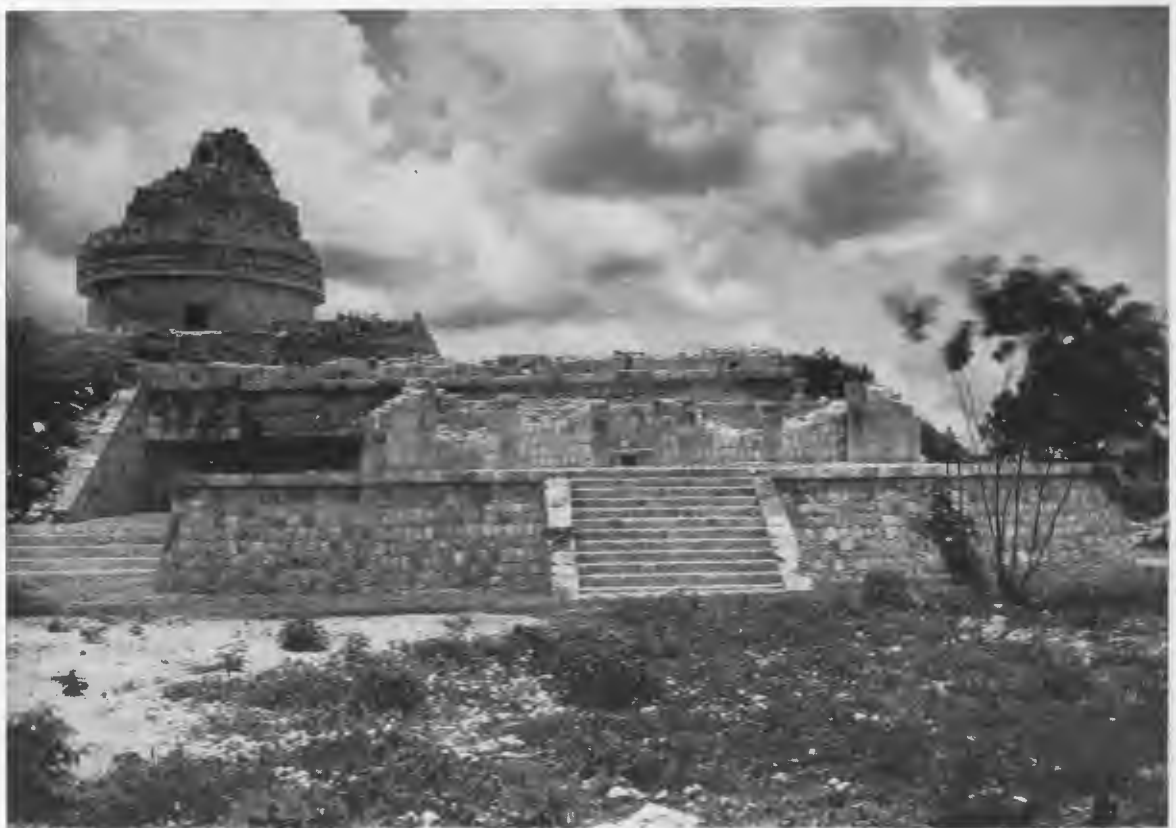
FIG. 304—CARACOL WEST ANNEX, VIEWED FROM WEST, REPAIR COMPLETED.

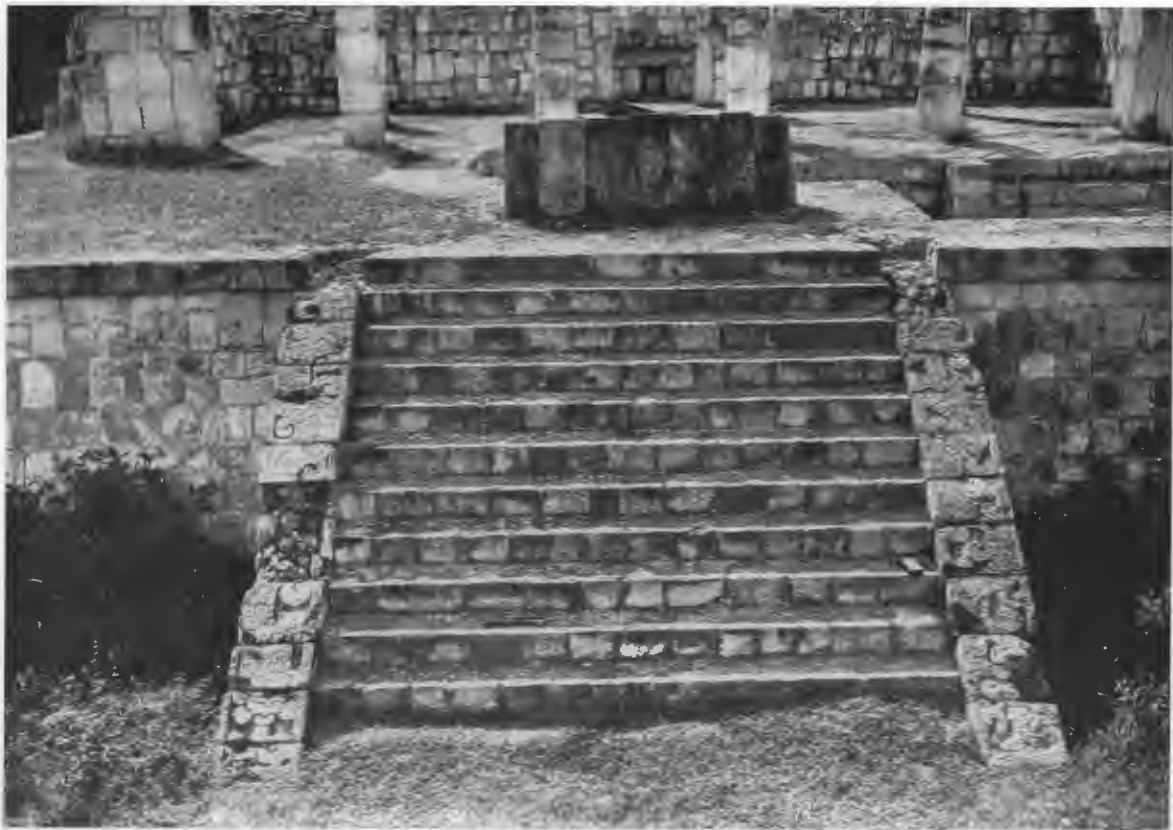
FIG. 307—West stairway repaired. Each balustrade bears a low-relief carving of a plumed serpent.

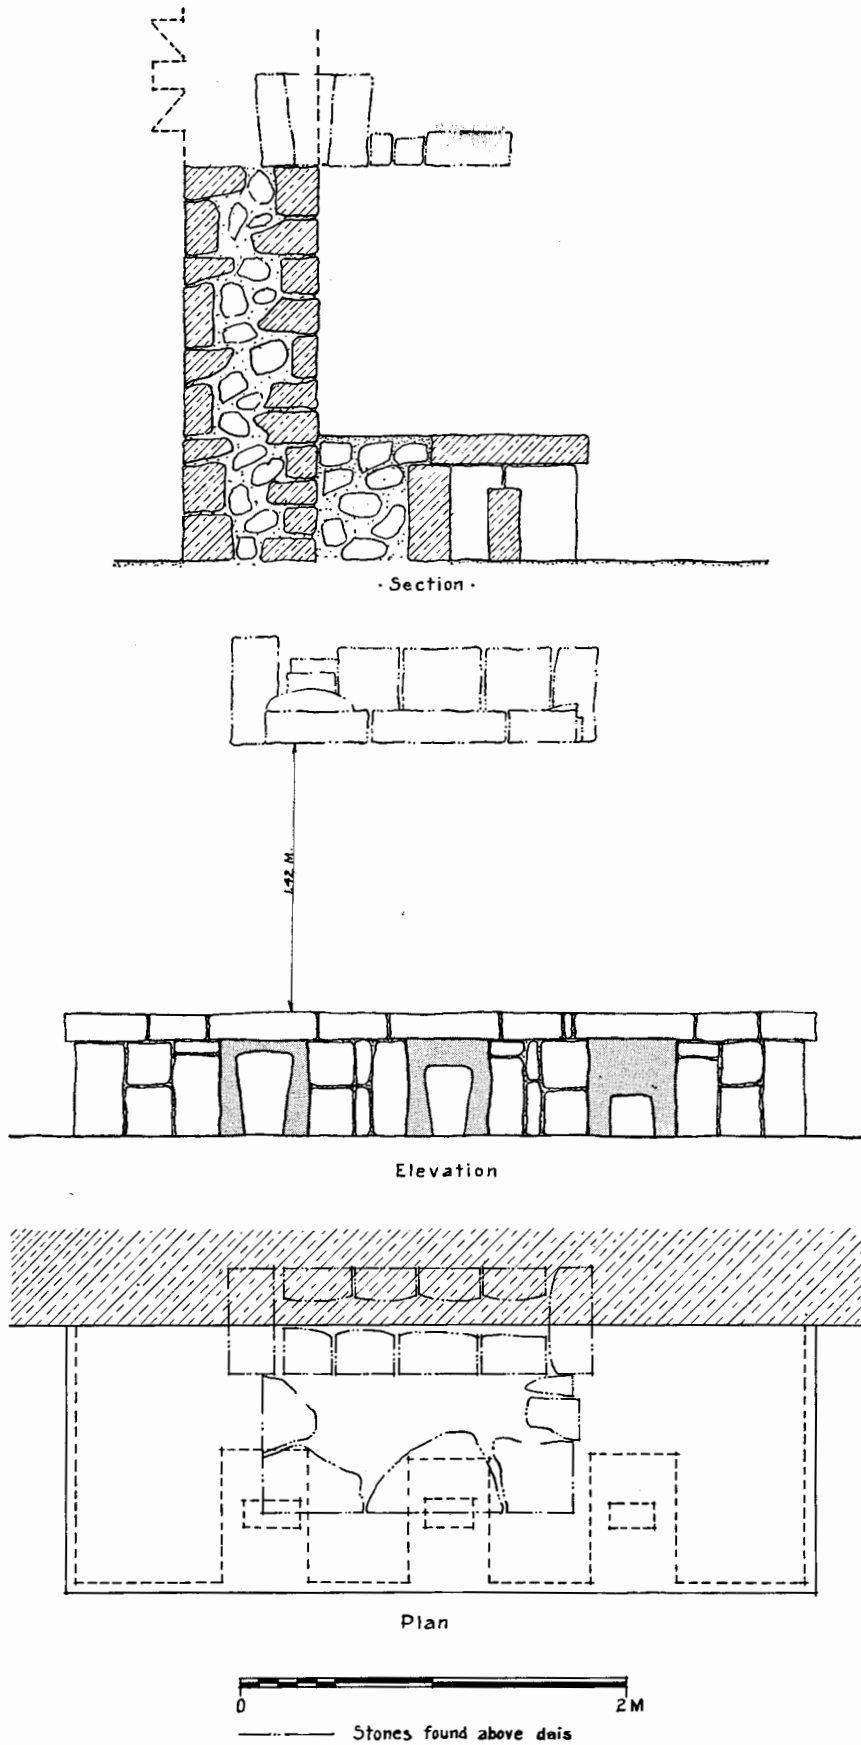
FIG. 325—PLAN, SECTION AND ELEVATION OF DAIS IN INNER CHAMBER OF WEST ANNEX, SHOWING STONES FOUND ABOVE DAIS.

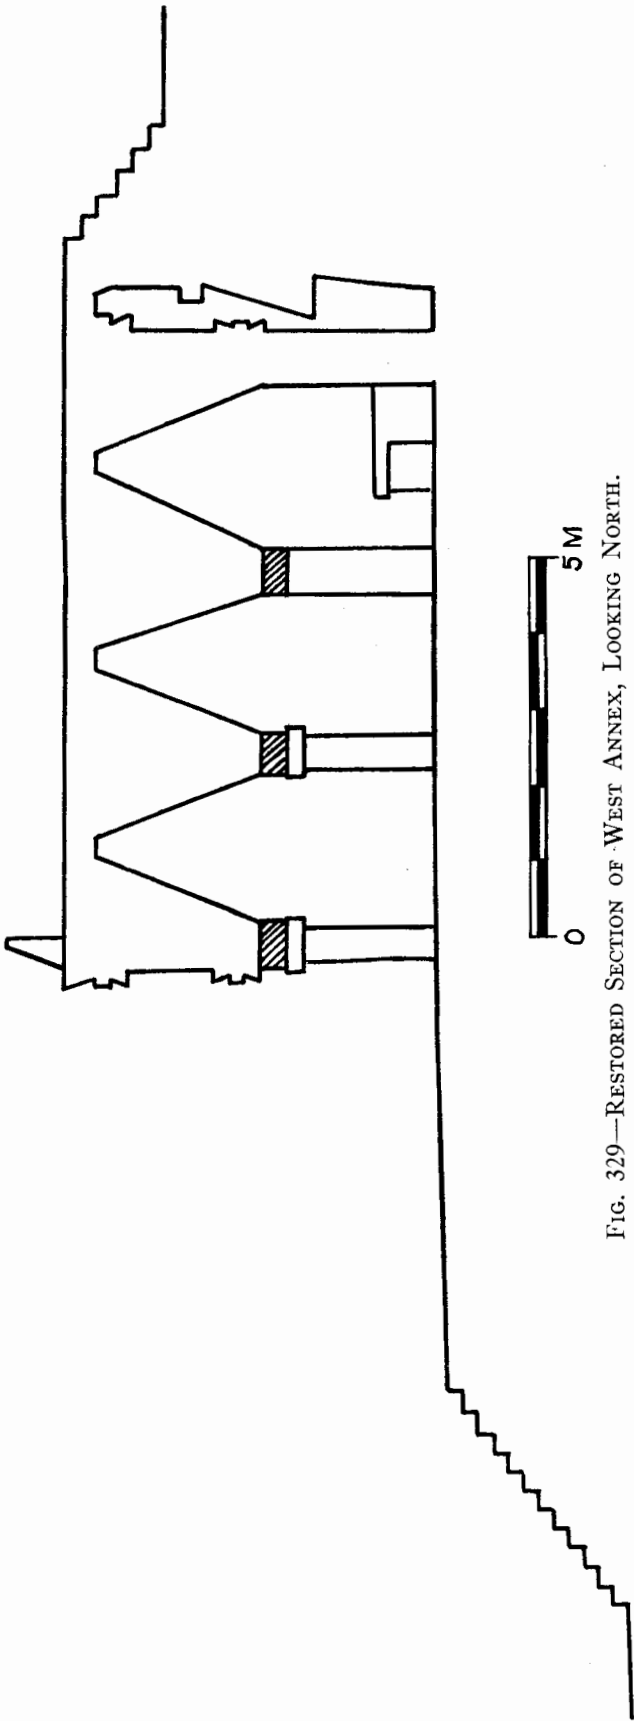
FIG. 329—RESTORED SECTION OF WEST ANNEX, LOOKING NORTH.
